Ruin conservation at Domkirkeodden museum, Hamar, Norway.

Trondheim 7-10th of September 2017

Anne Kathrine Bakstad

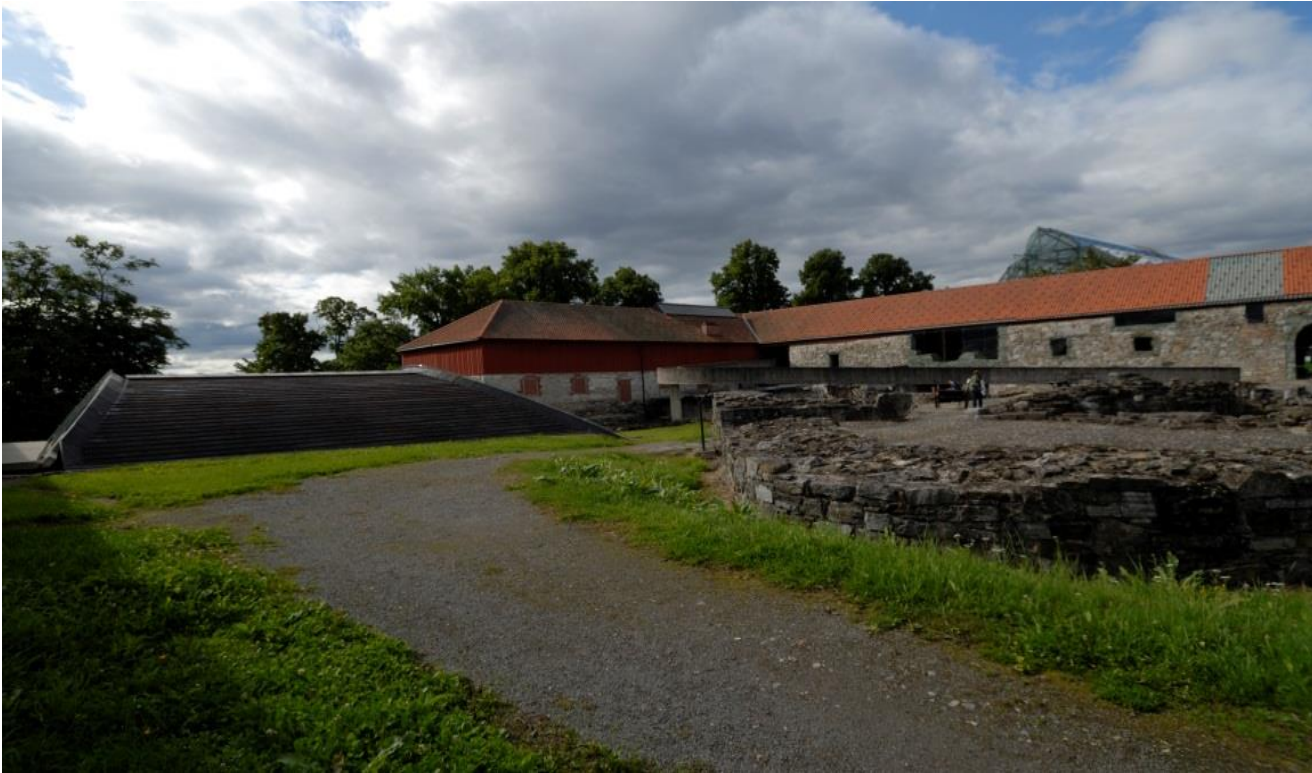
The medieval diocese of Hamar:

- From the period between 1152-1537 we have ruins of the cathedral(1), the bishops fortress(2), the cathedral school (3)and several houses for the bishops canons(4). There is also ruins of a castellum(5) and the Cross church(6). The area probably also include the unexcavated ruins of the St. Olufs monastery (Dominican)(7).

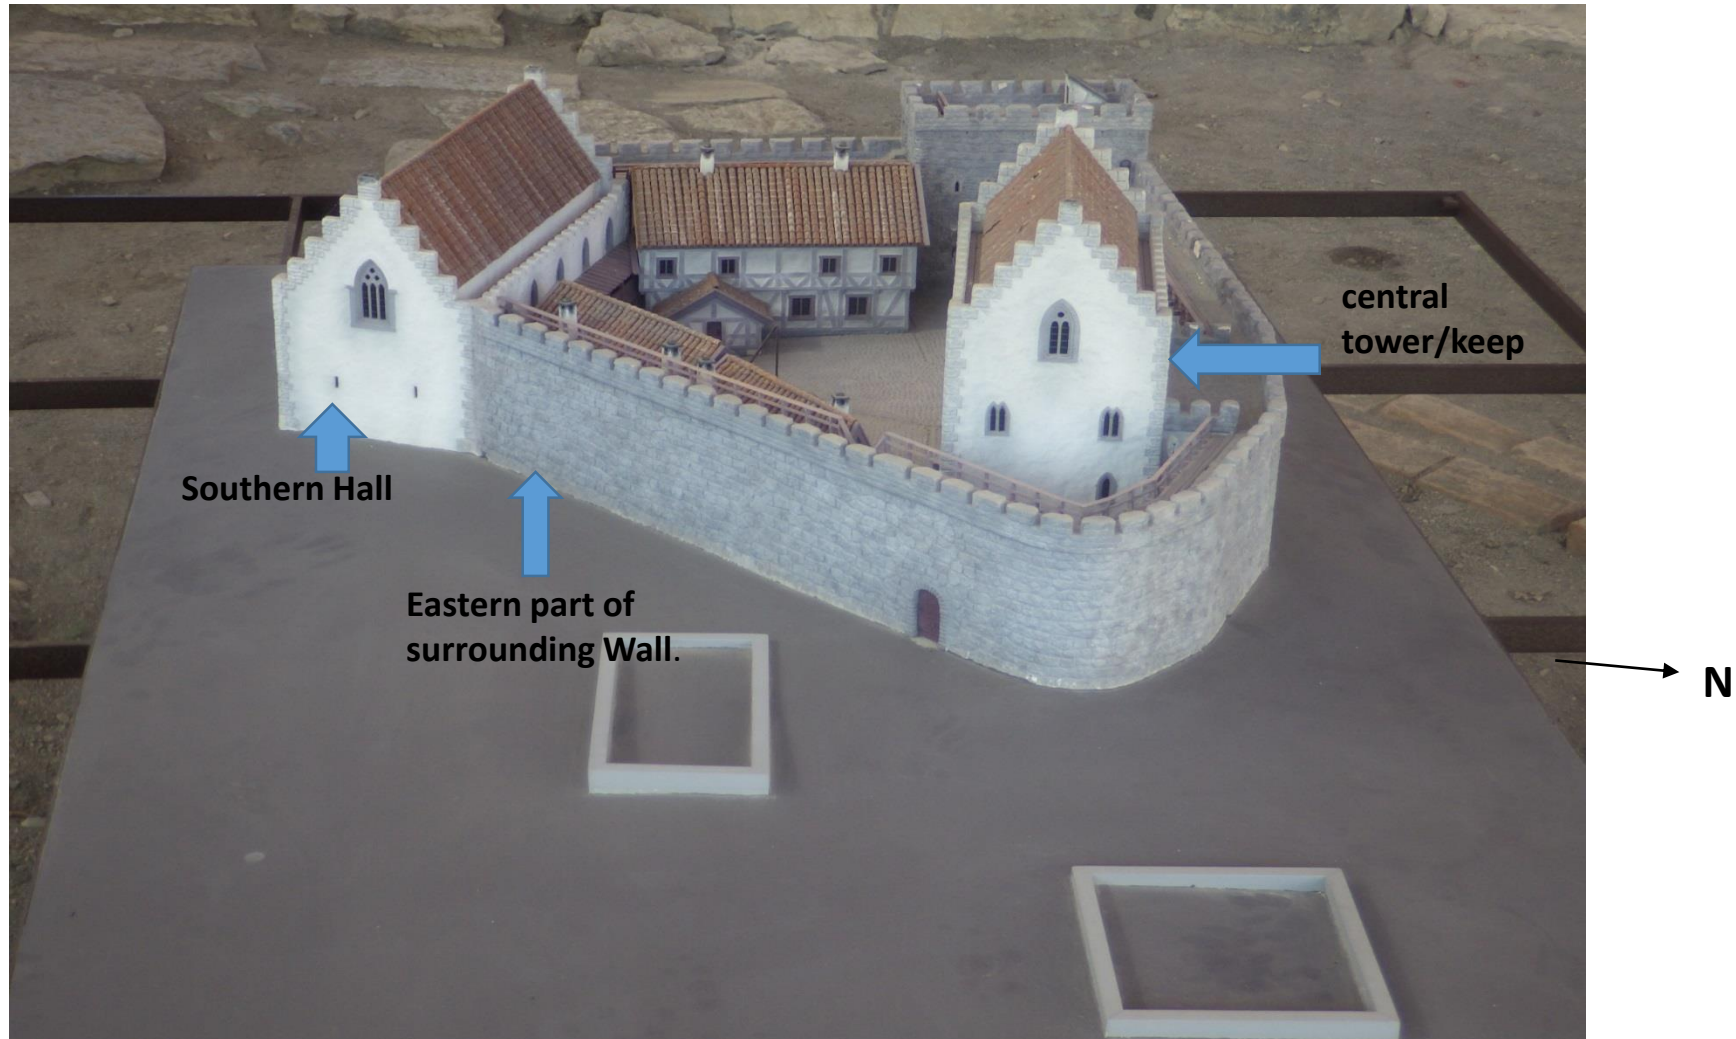
Model of the bishops fortress from 1450

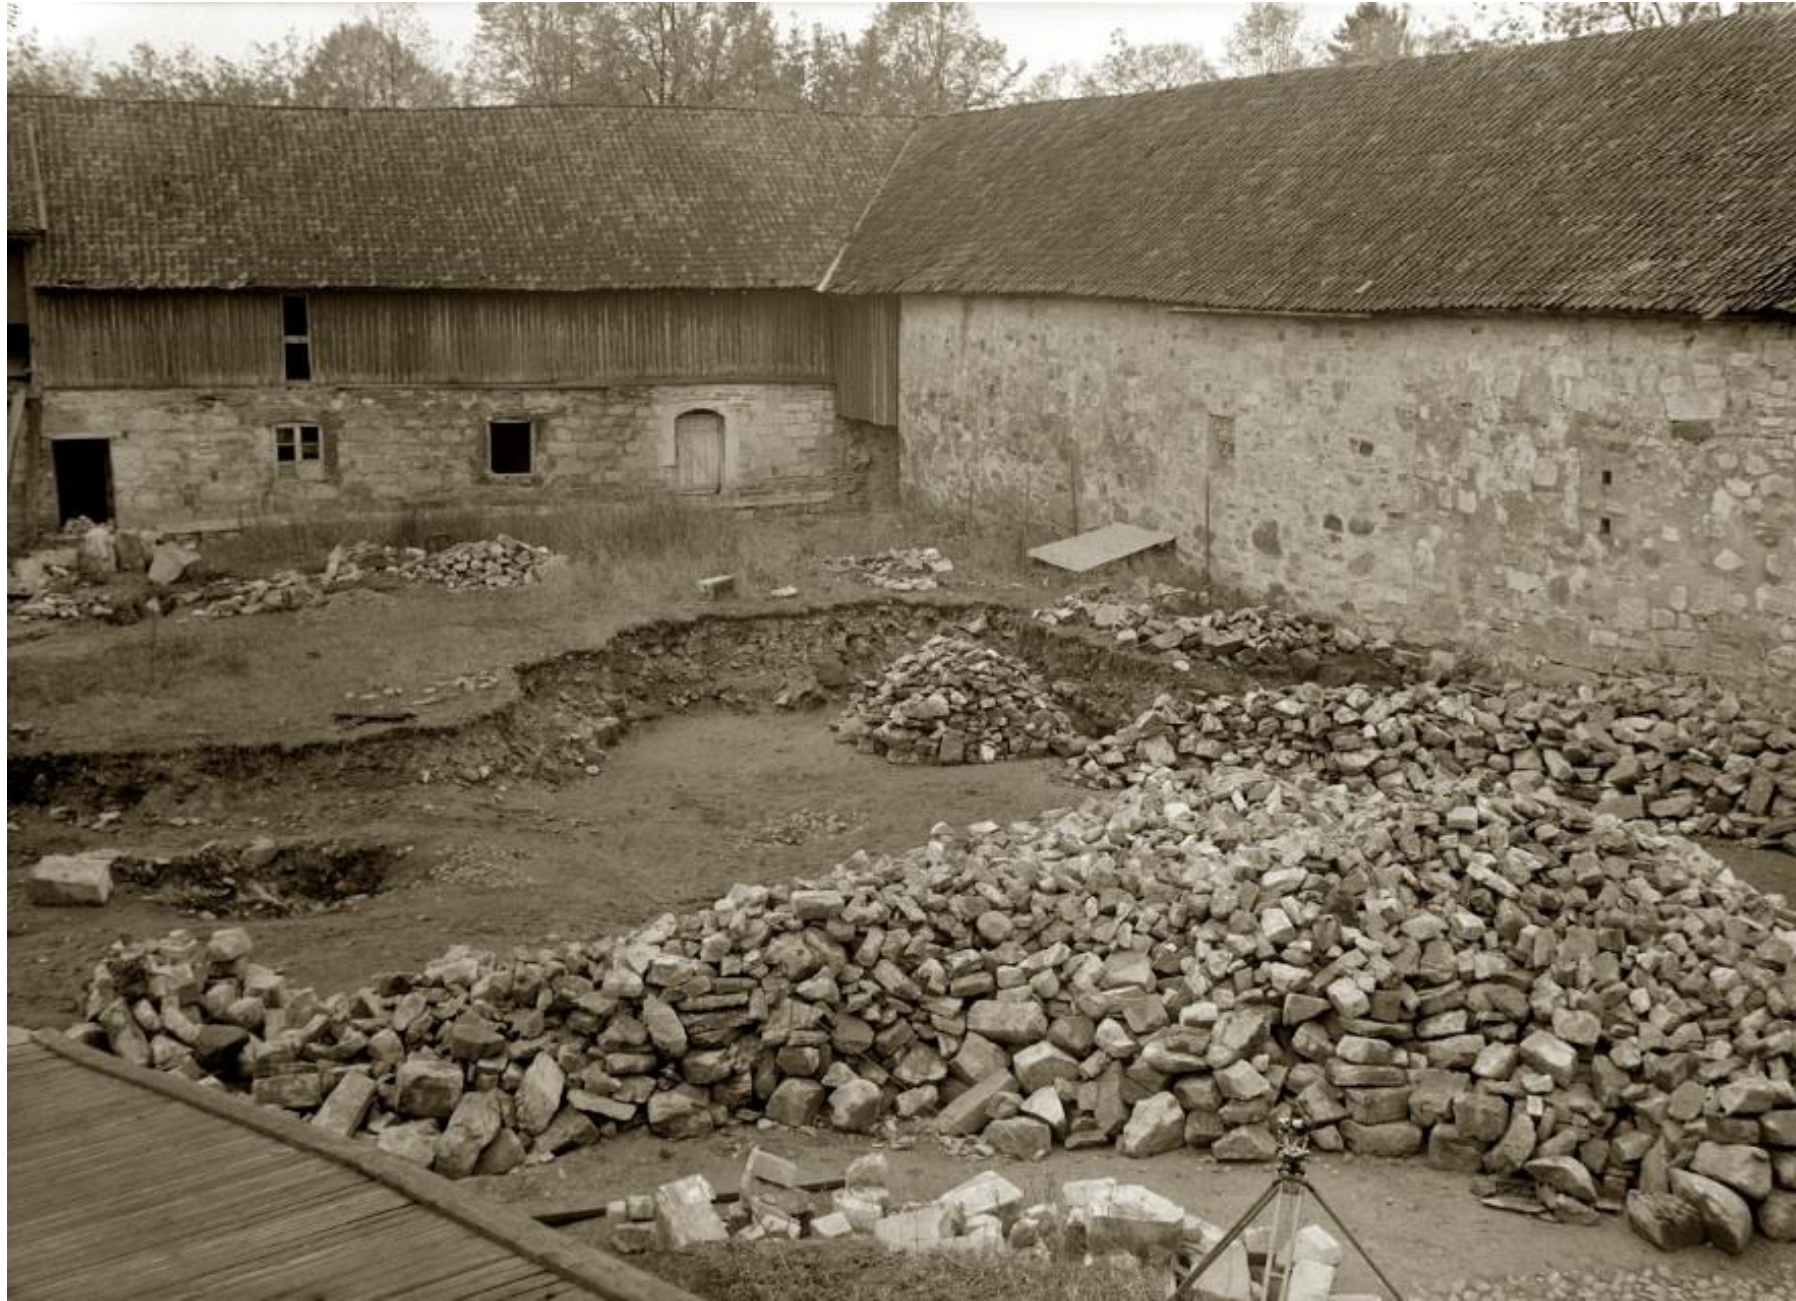
Excavations in the bishops courtyard from 1947.
(G. Fischer, H. Christie, T. Bleken-Nilssen)

- **After the excavations of the bishops fortress between 1947-63, the ruins were repaired with cement/concrete.**
- **Our project is to replace the concrete with lime mortars. Until now we have used a non-hydraulic lime mortar, hotmix. The pure and non-hydraulic lime (about 99% clean) from Frantzefoss. We also use an aggregate of sand coming from Ramlo, size 0-4 mm.**
- **The hydraulic lime NHL 3,5 has been used for the two upper shifts and for the hard top.**
- **We finish our conservation with a soft top consisting of bentonit clay and roll-on turf.**

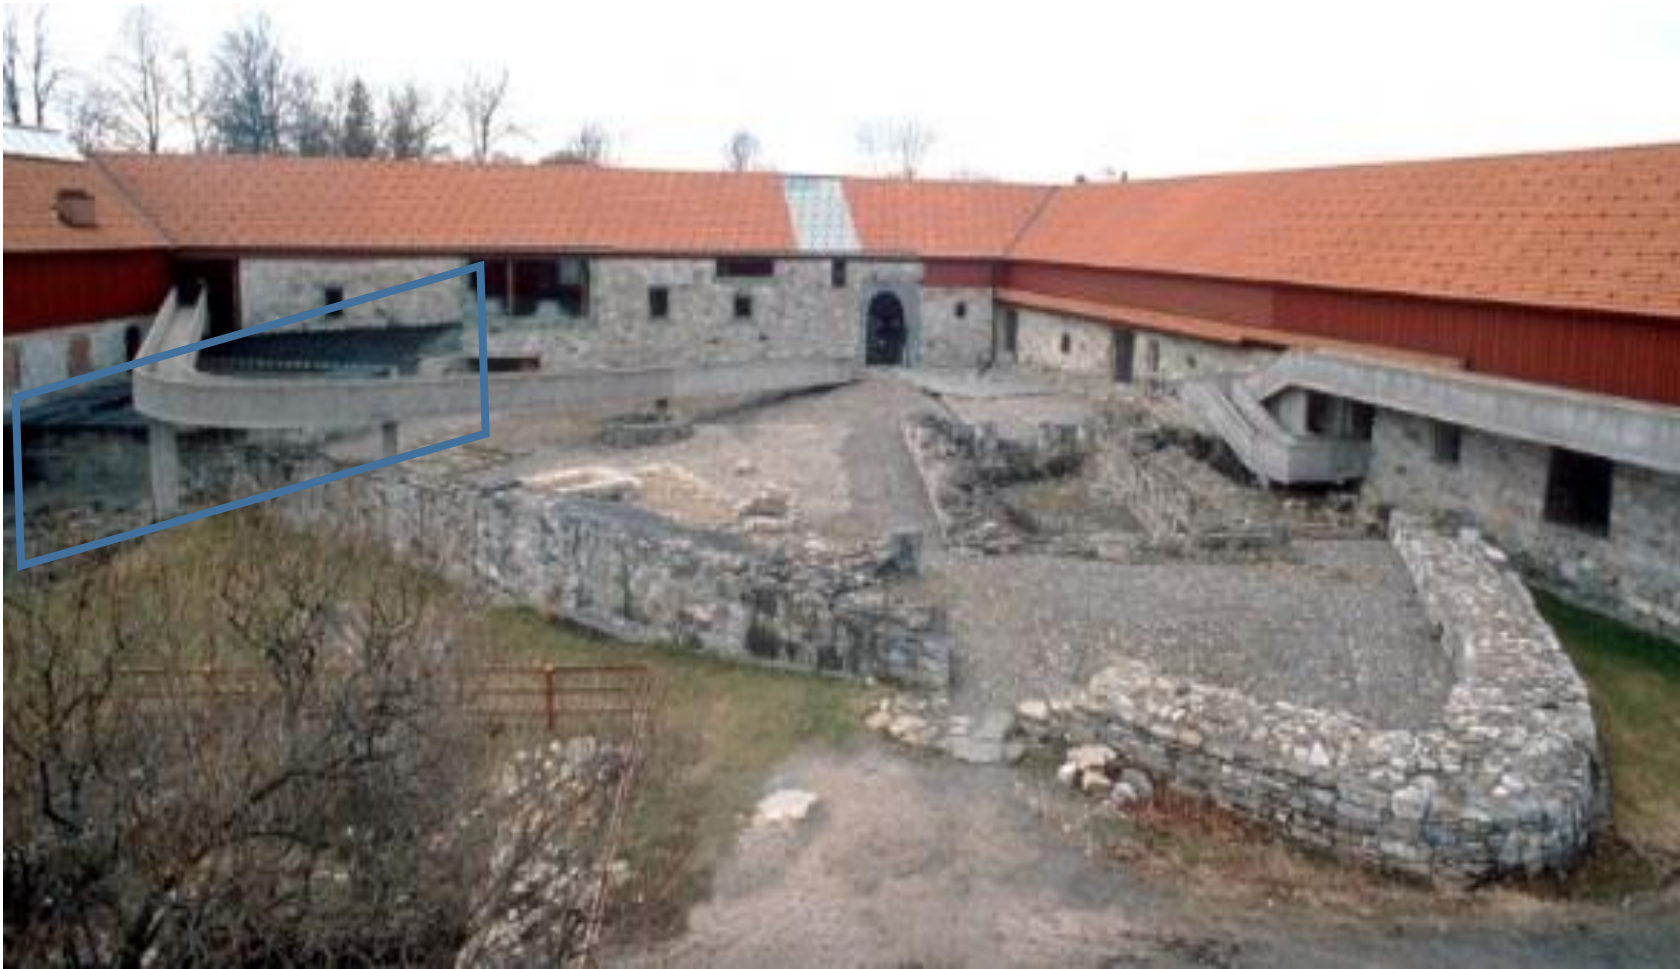
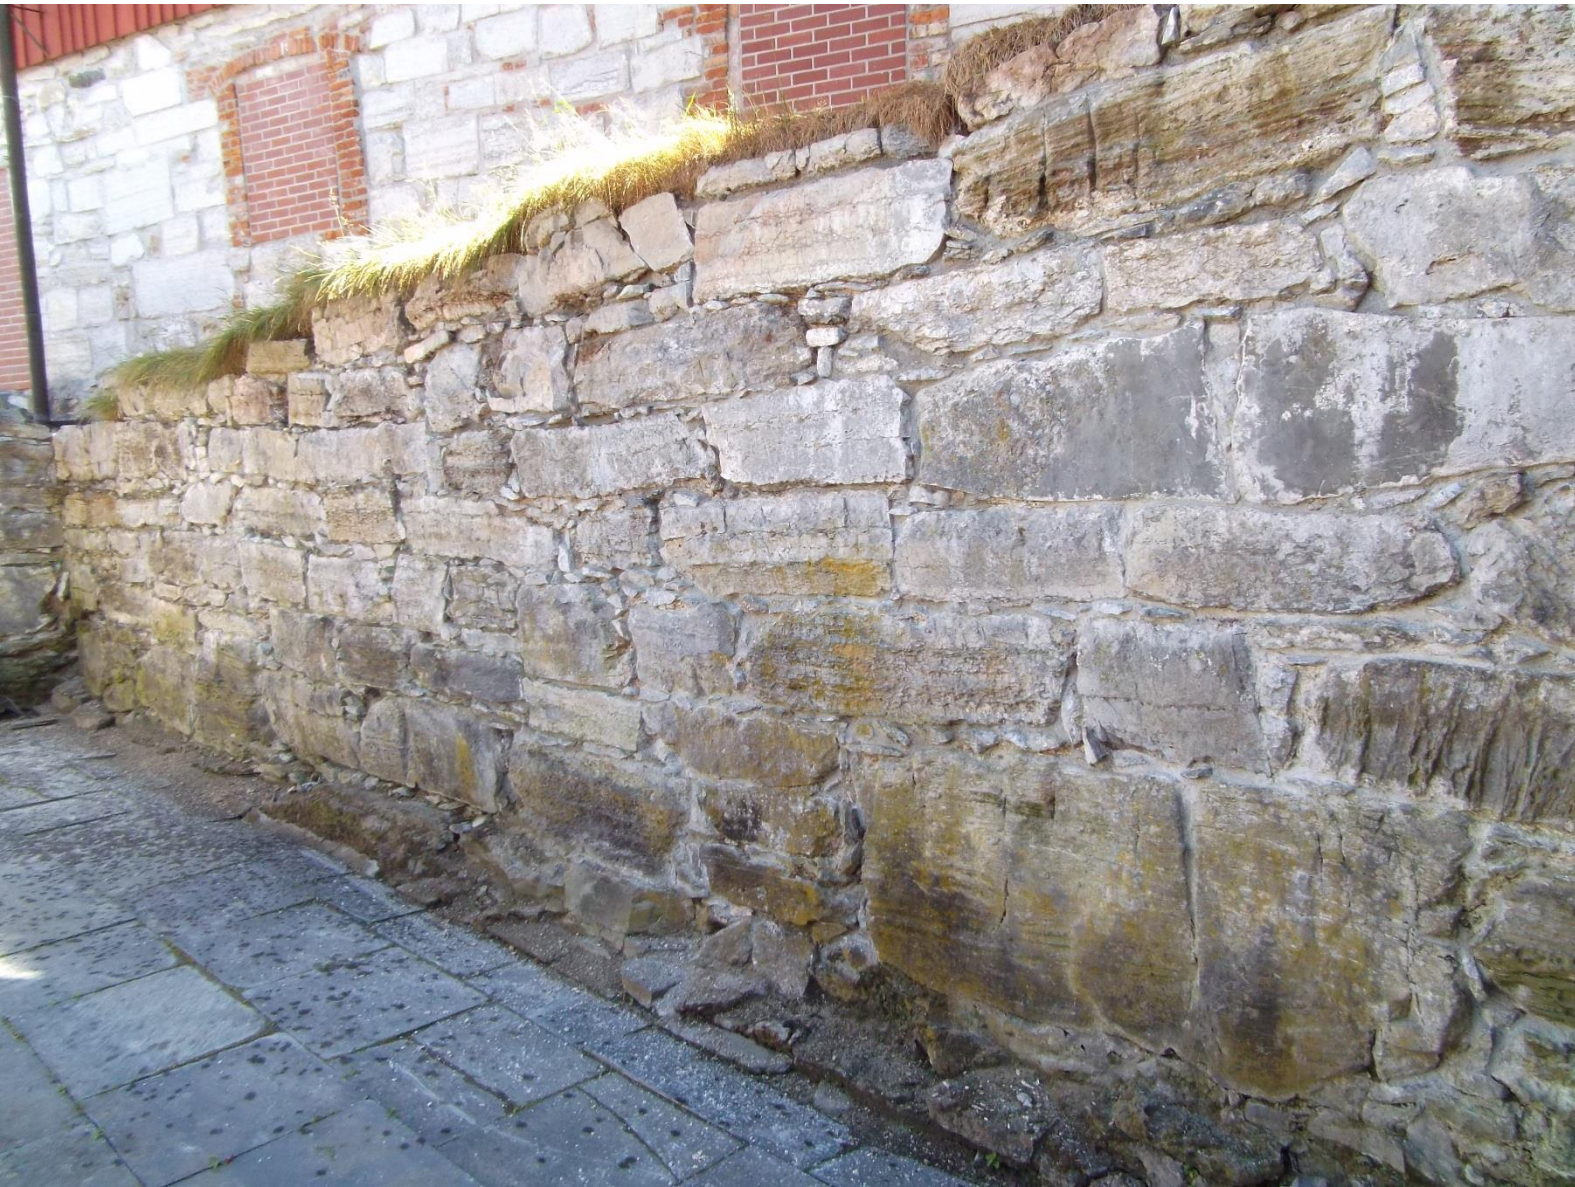
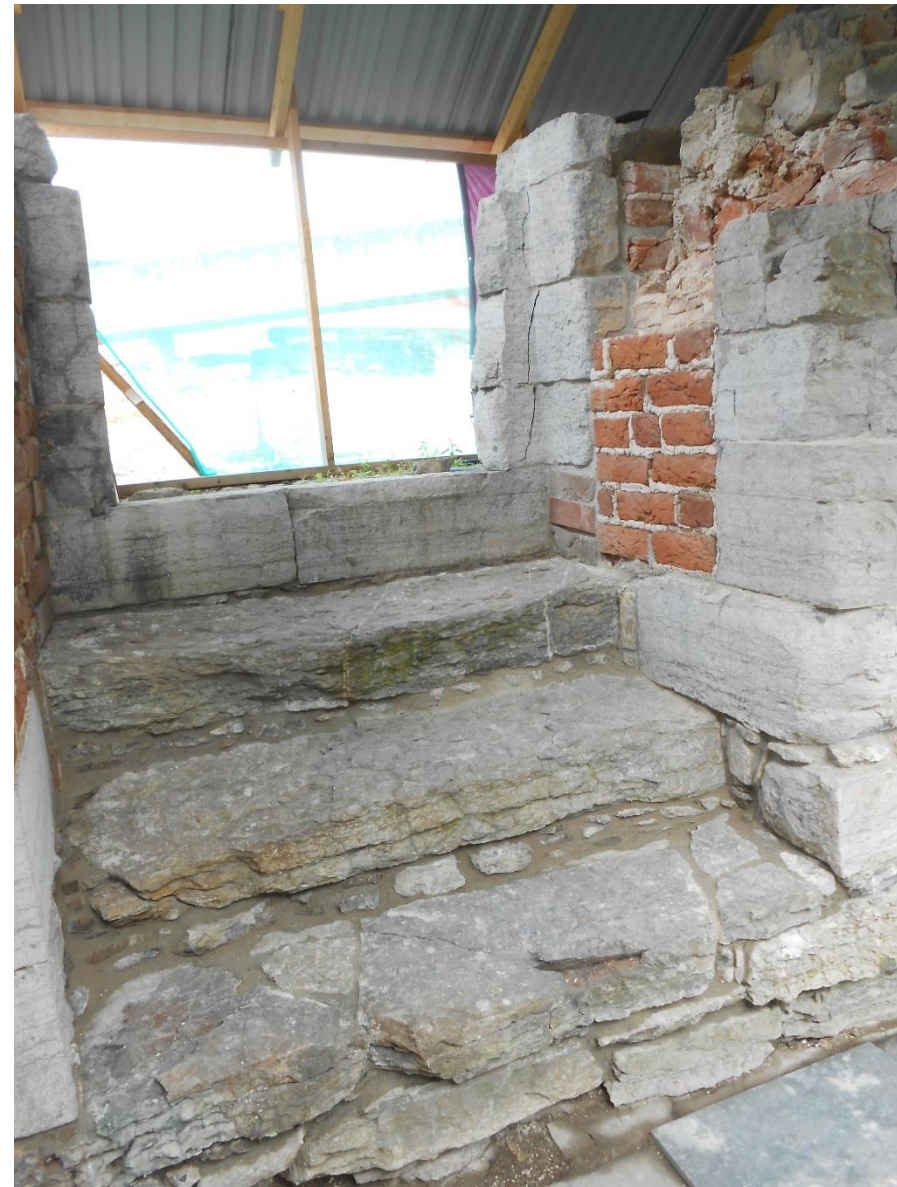
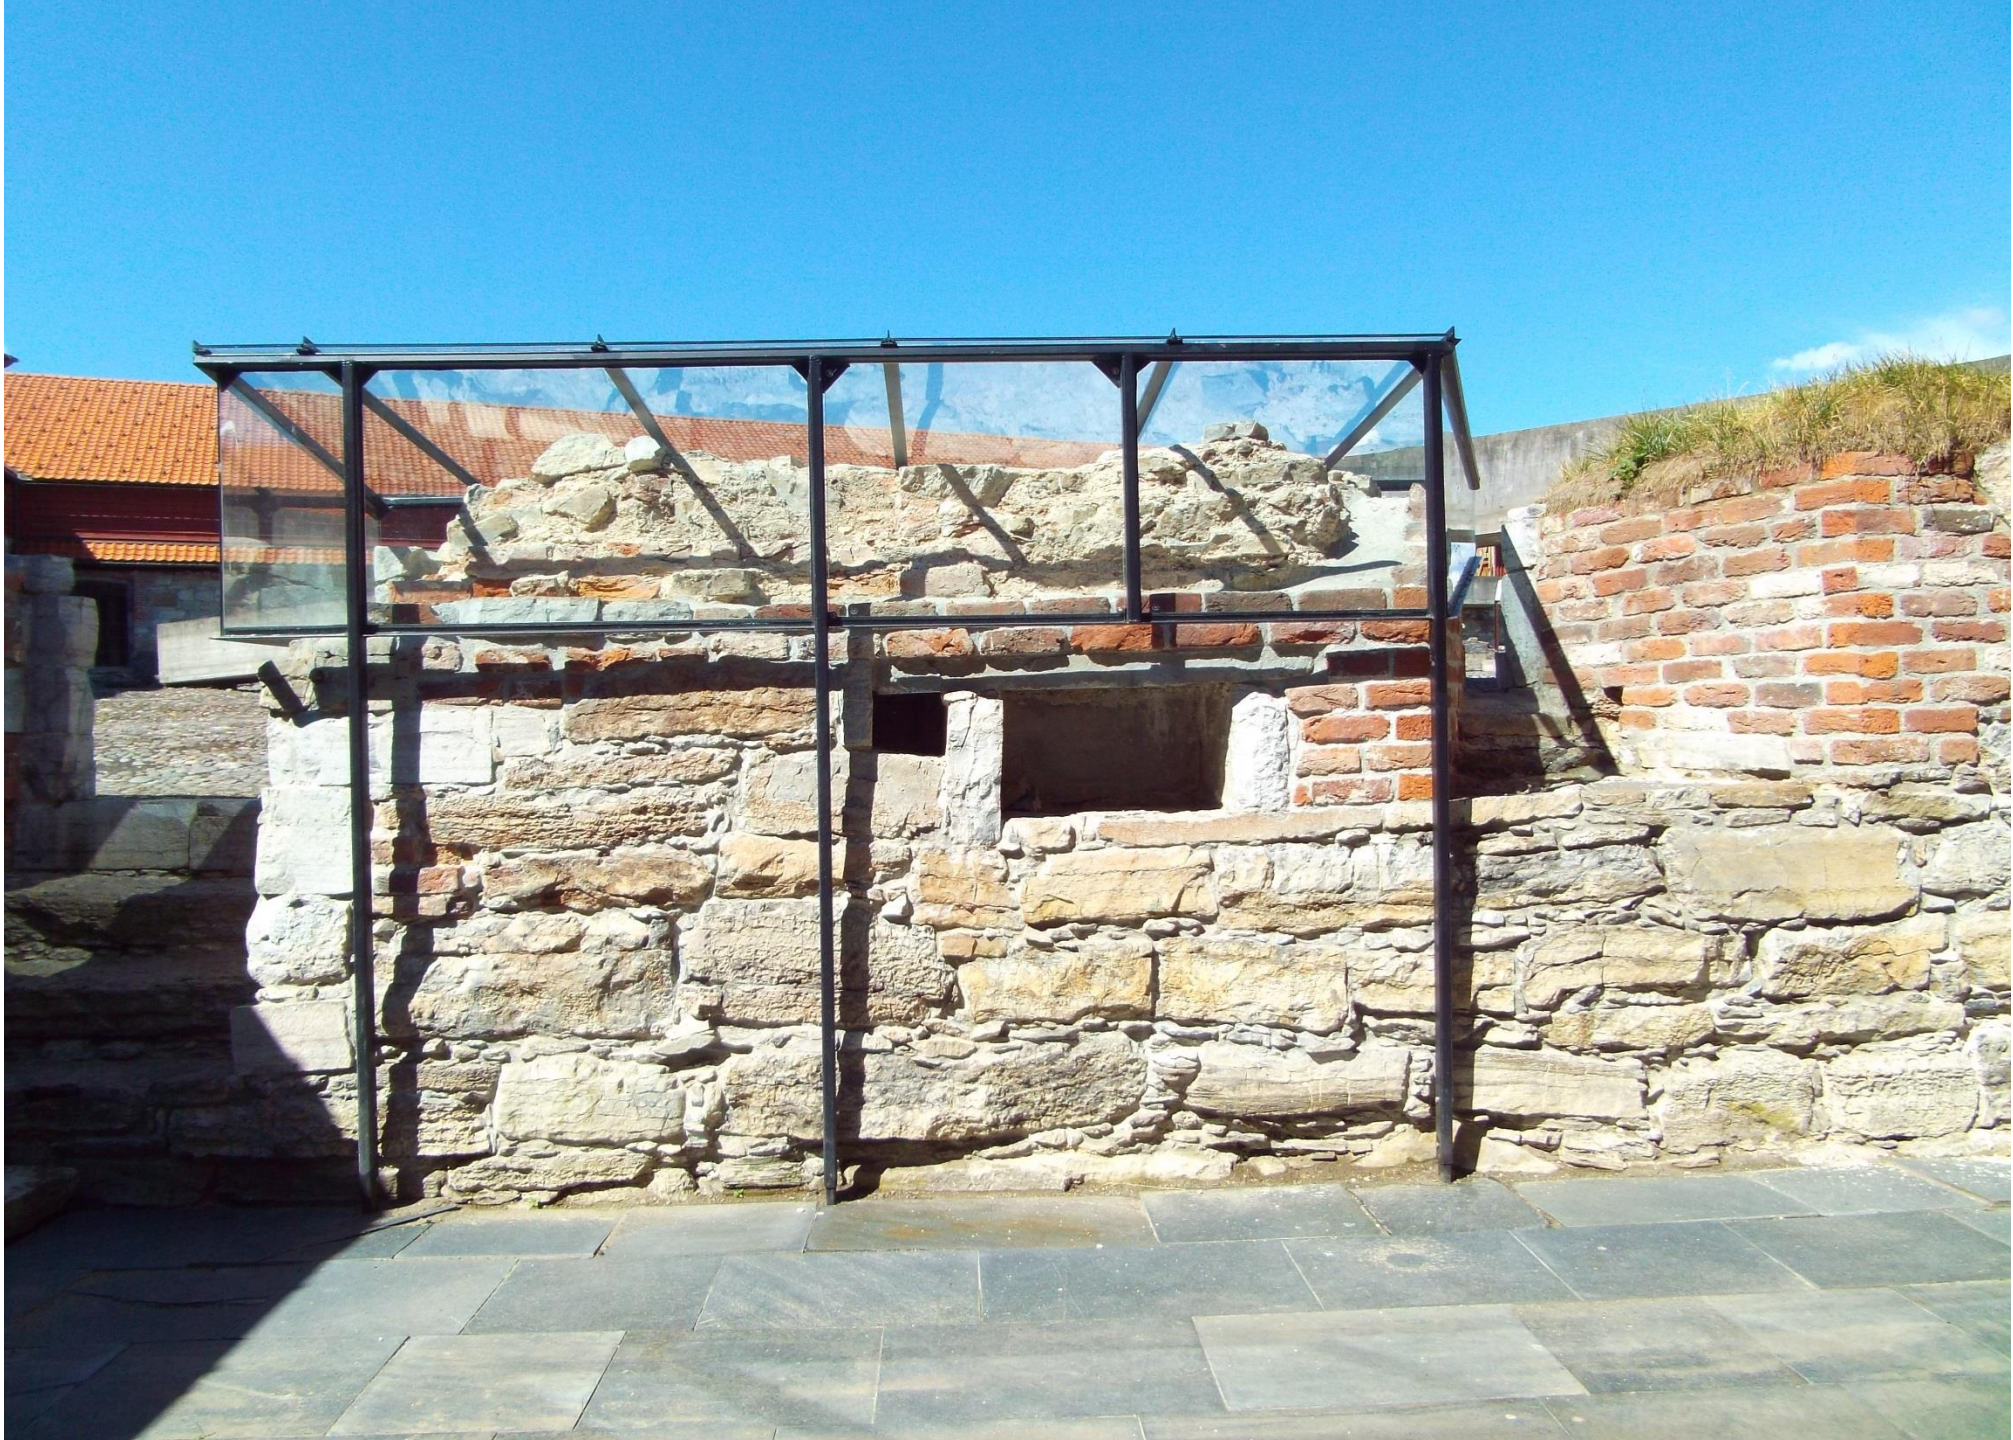
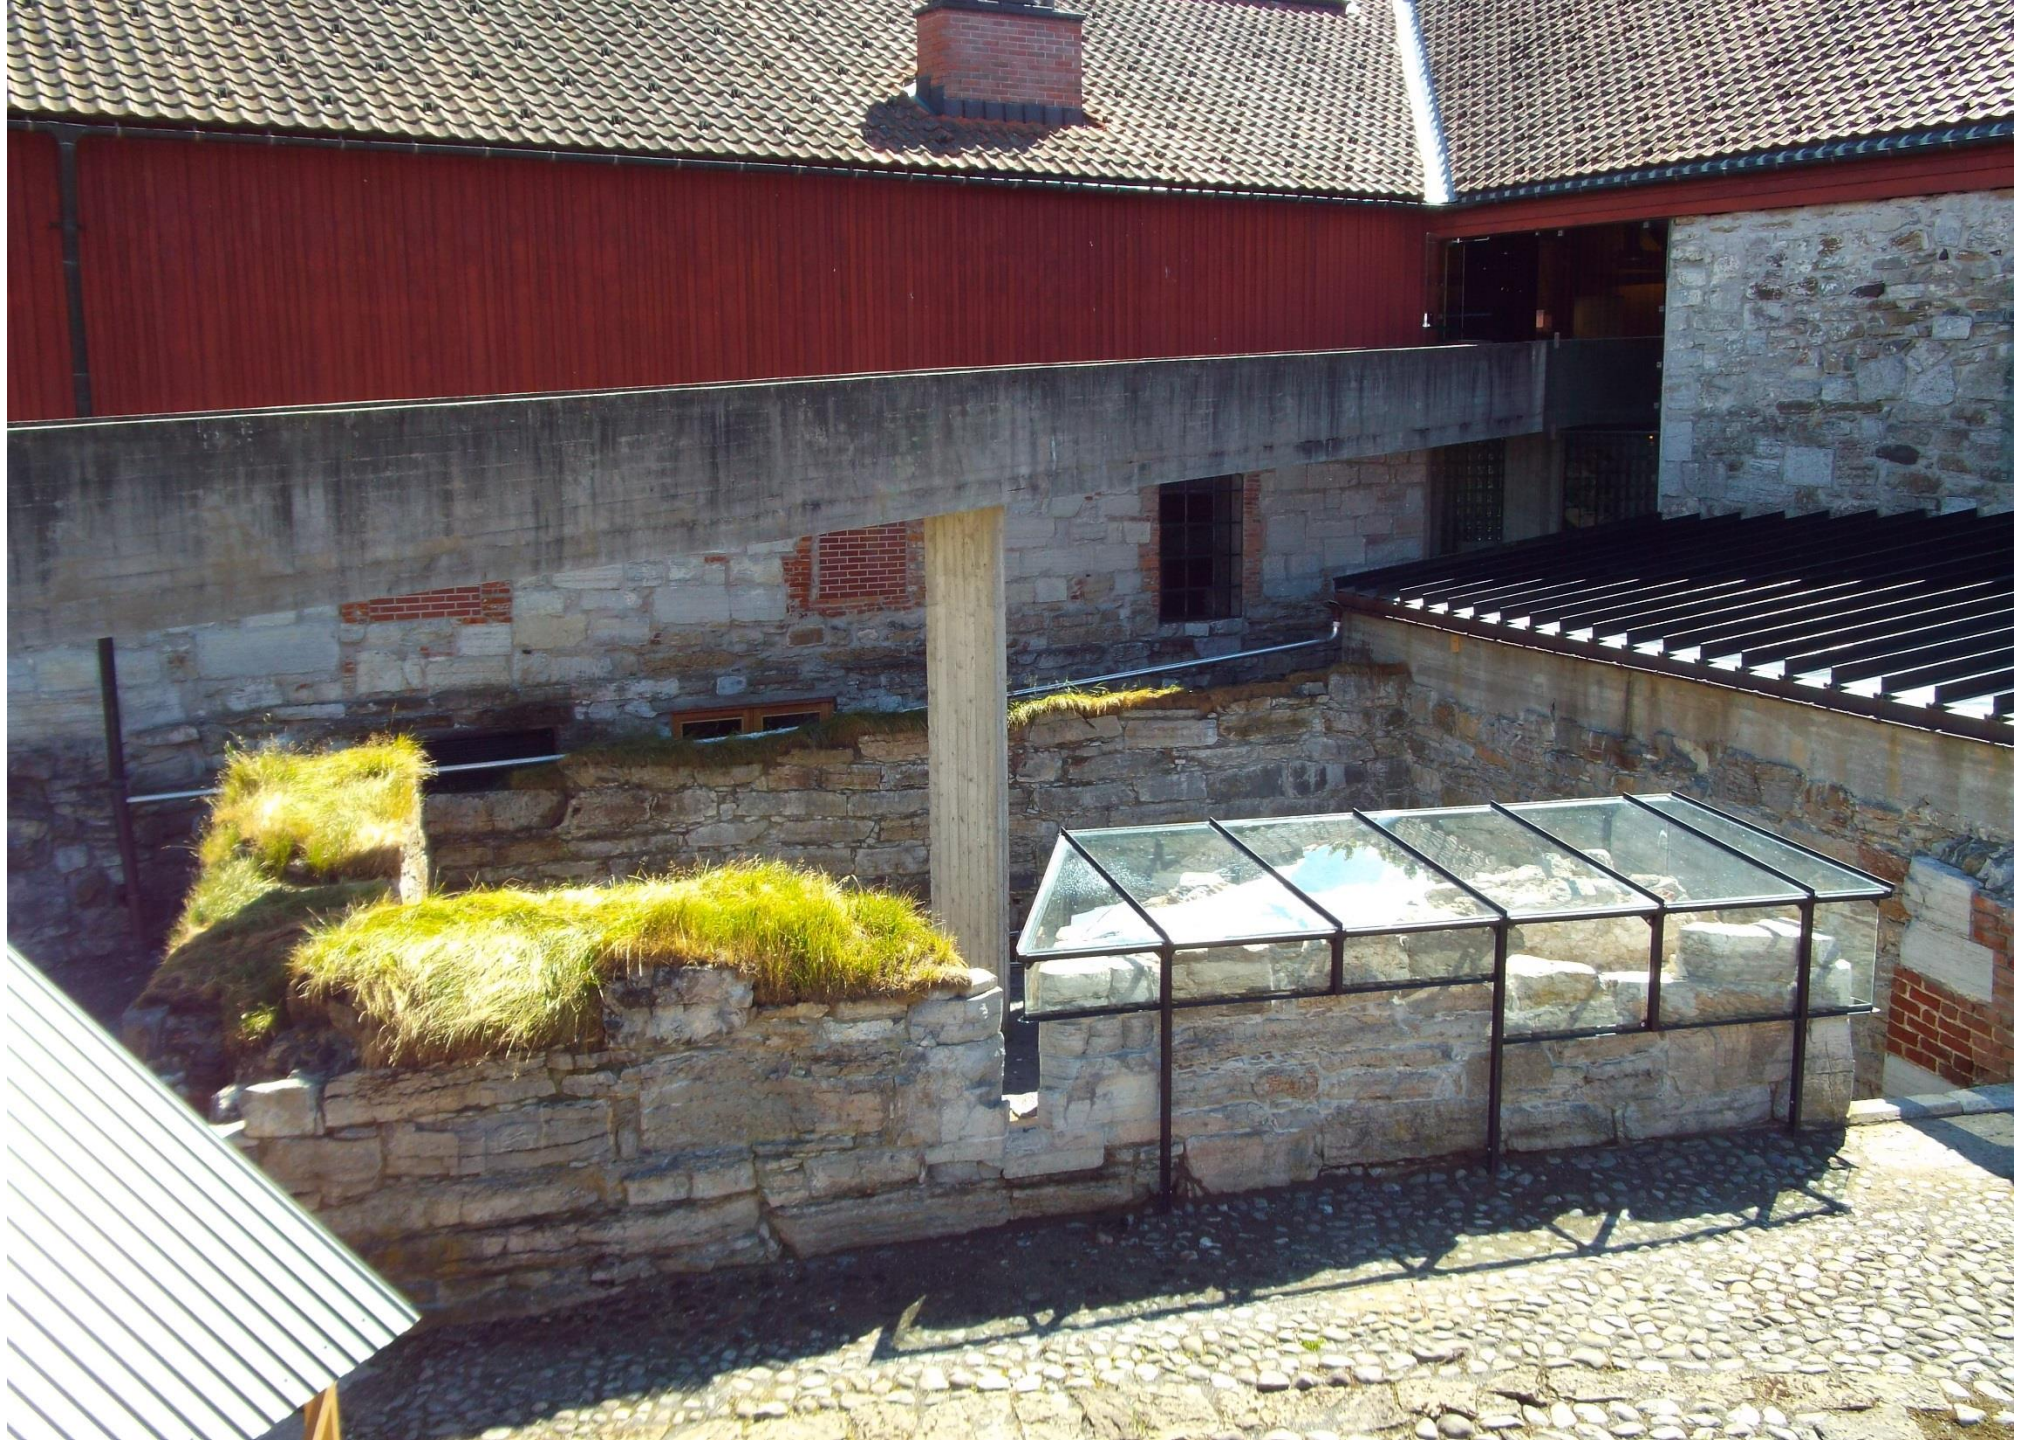
Conservation of the eastern room in the southern hall 2011-2014

- The building has recently been carbon dated by bones found in the lime core, dating back to 1219-1284.(95,4%)
- Two of originally three basement rooms can still be seen.
- The southern room was conserved in the 1970s and a roof was added by architect Sverre Fehn.

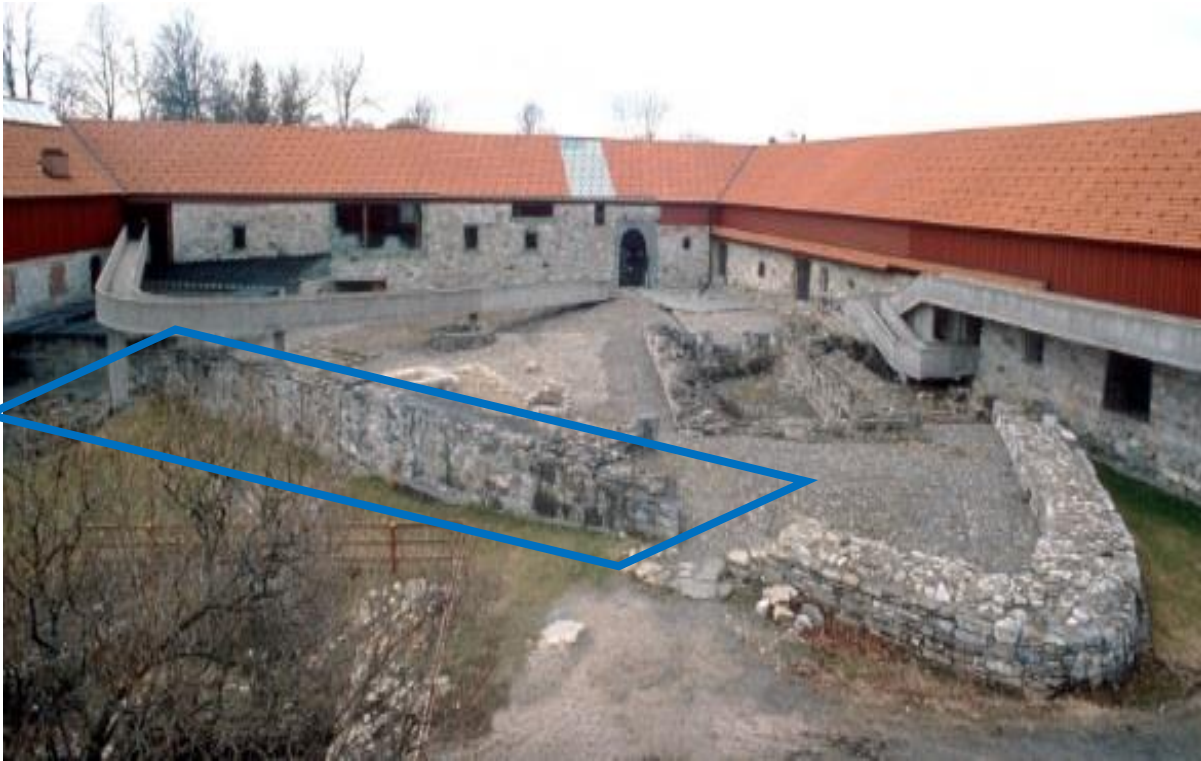
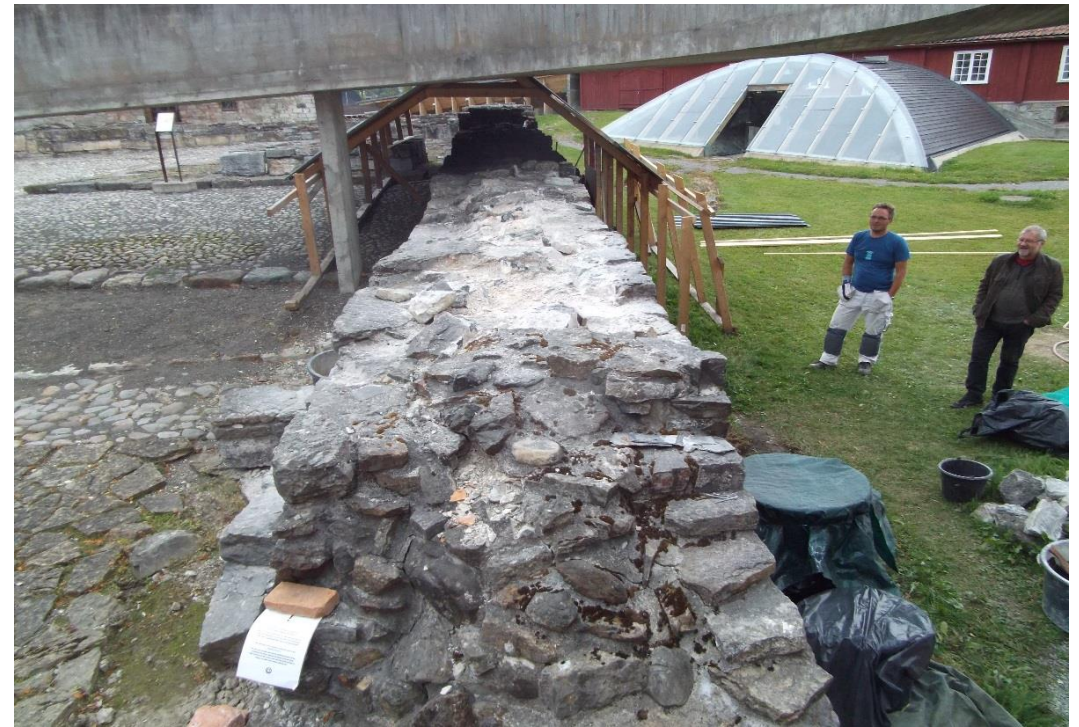
Conservation of the eastern part of the surrounding wall, 2014-2016

- We assume that the eastern wall was built in the second half of the 15th century.
- The new wall reduced the protected area of the courtyard. At least three known buildings were left outside.
- 33 m. length
- 0,7 - 3,5 m. high.
- 1,6- 1,7 m. thick.

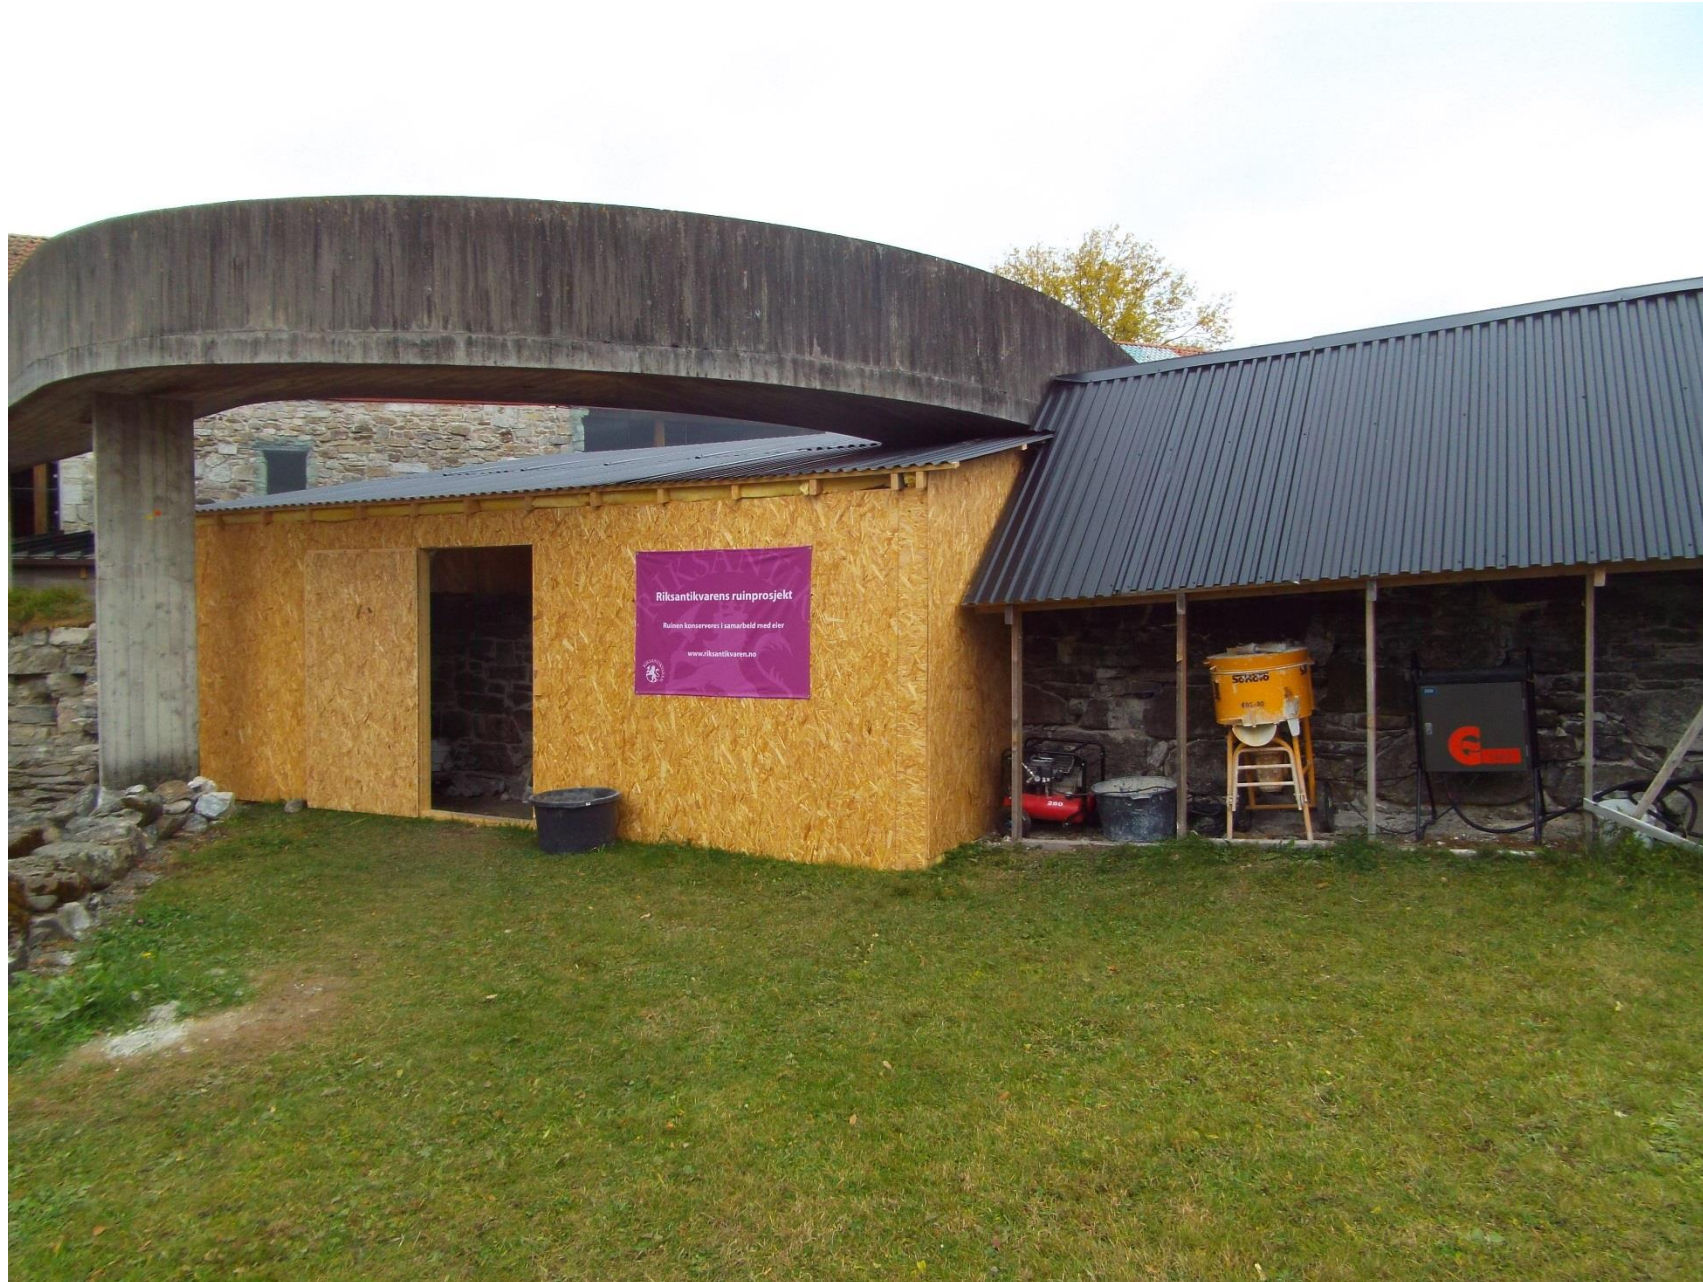
A heated and insulated house makes ruin conservation possible also in wintertime.
