Ruin conservation at Domkirkeodden museum, Hamar, Norway.

Trondheim 7-10th of September 2017

Anne Kathrine Bakstad

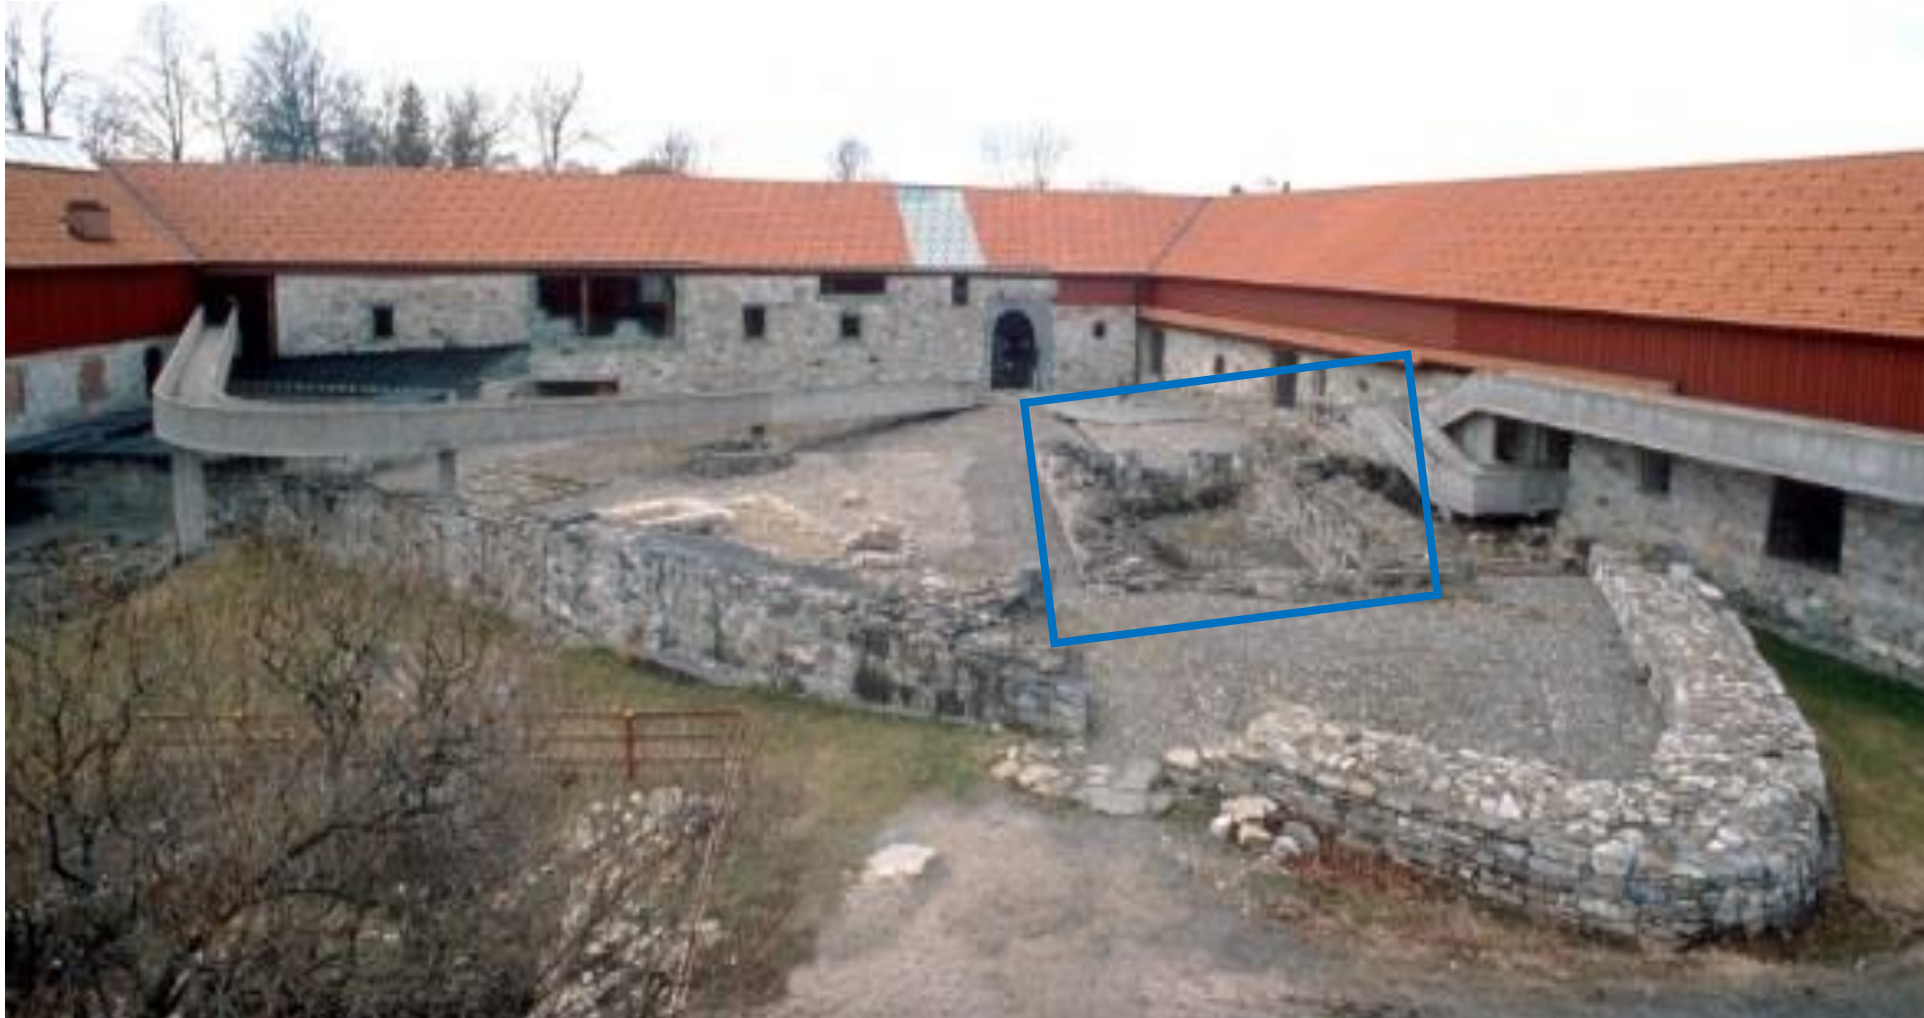
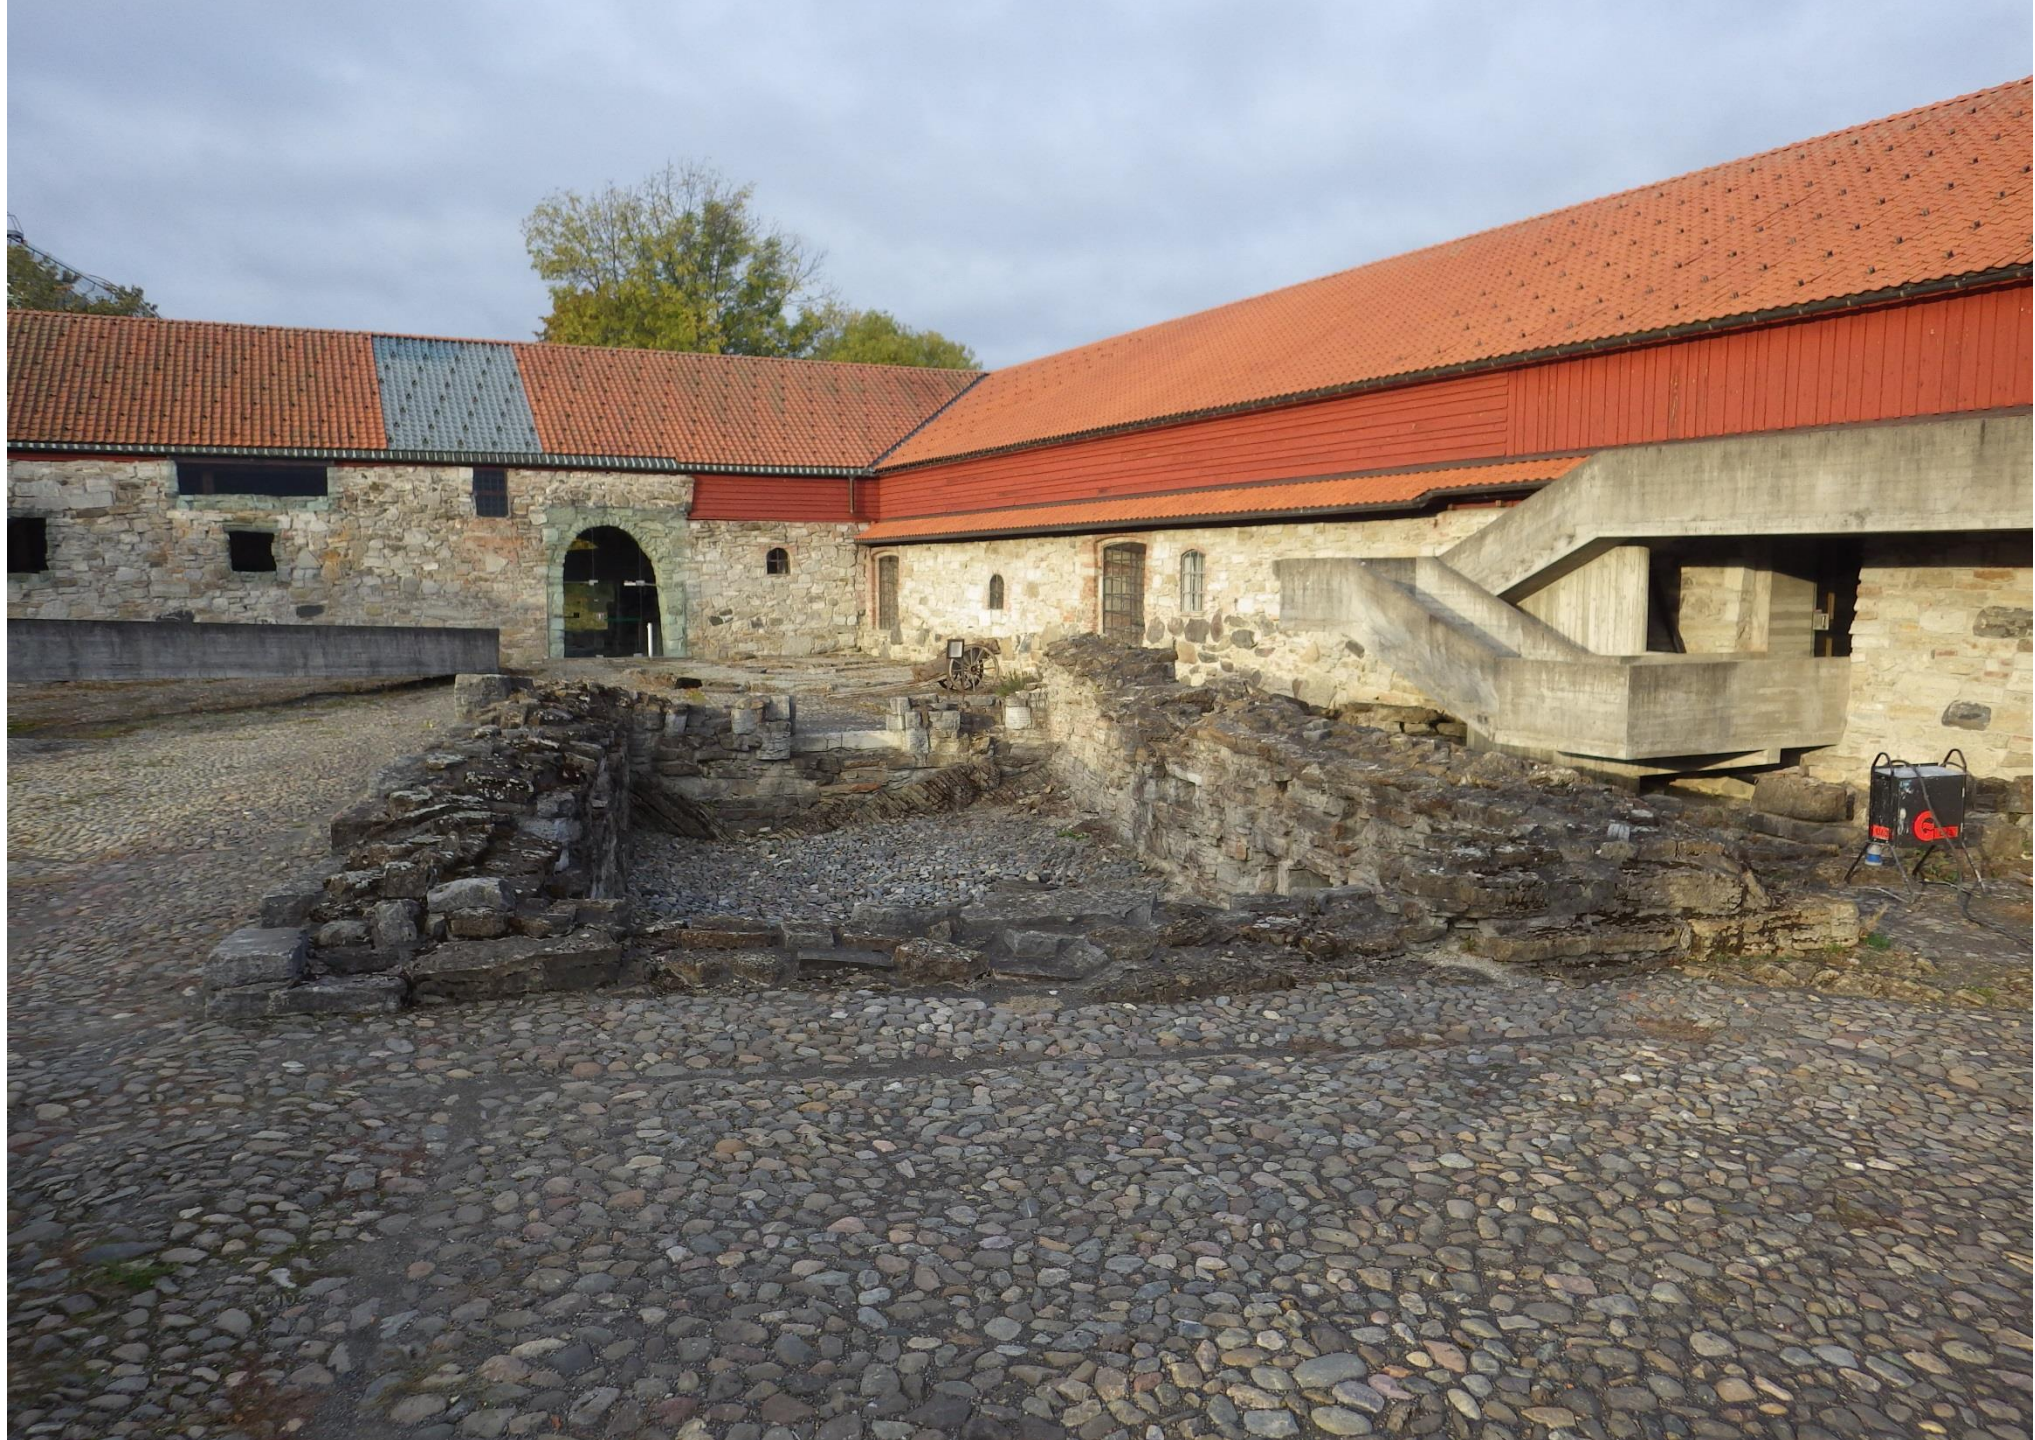
Conservation of the main tower/ keep 2017-2019.

- The building has recently been carbon dated by charcoal found in the lime core, dating back to 1169-1270. (95,4%)
- We have started to try out our own lime mortar in a part of this building.

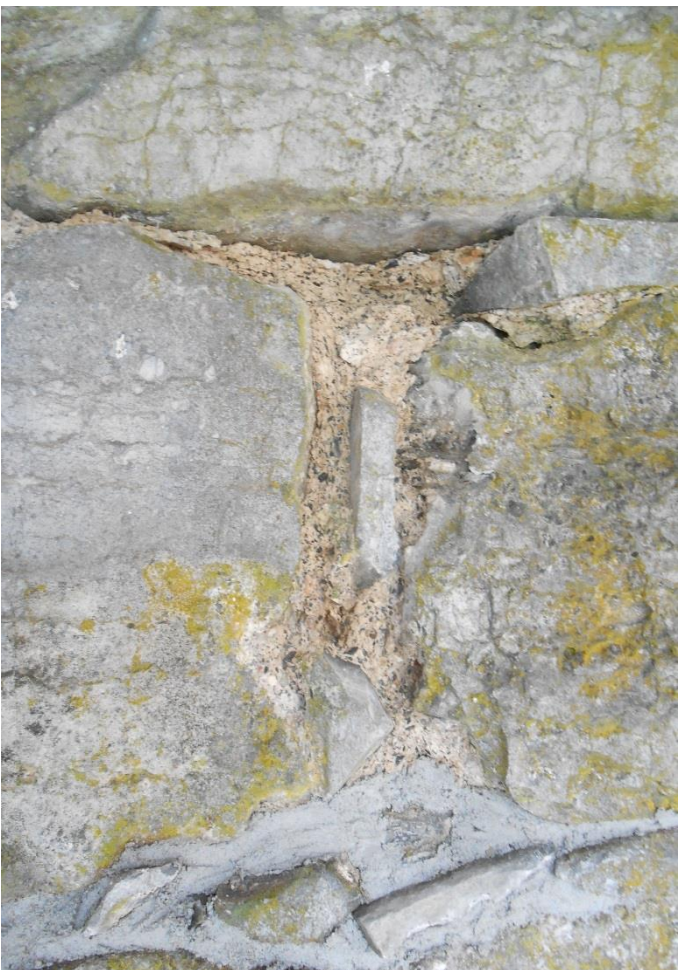
← Lime mortar from joint in the southern hall

Lime mortar from joint in the keep. →

Mortar from the lime core in the eastern wall

- Contains a lot of aggregate, especially the black sand of slate coming from the shores of lake Mjøsa.
Generally this is a rough aggregate containing all sizes from 0-15mm.
- The lime mortar used in the joints contains the same type of aggregate as the core, but the slate is of a smaller size, 0-7mm.
- The lime cores has parts of pure lime, especially seen in the eastern surrounding wall.
- It also seems that the lime generally used in the cores contains lime stones that are not sufficiently burnt.
- A lot of charcoal is also found in the lime cores, as well as bone material.

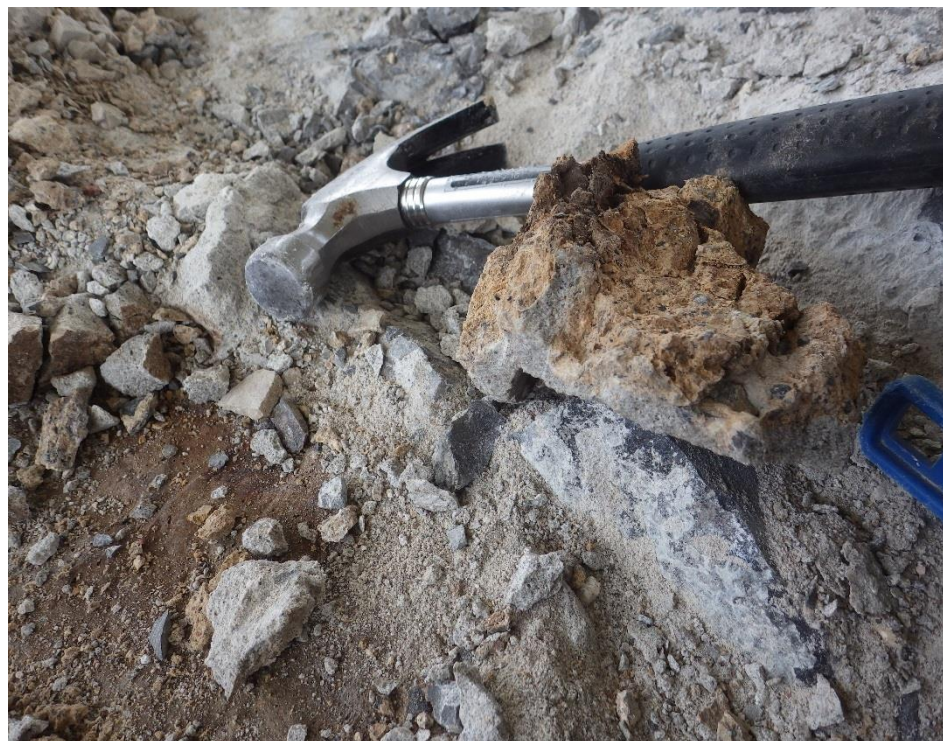
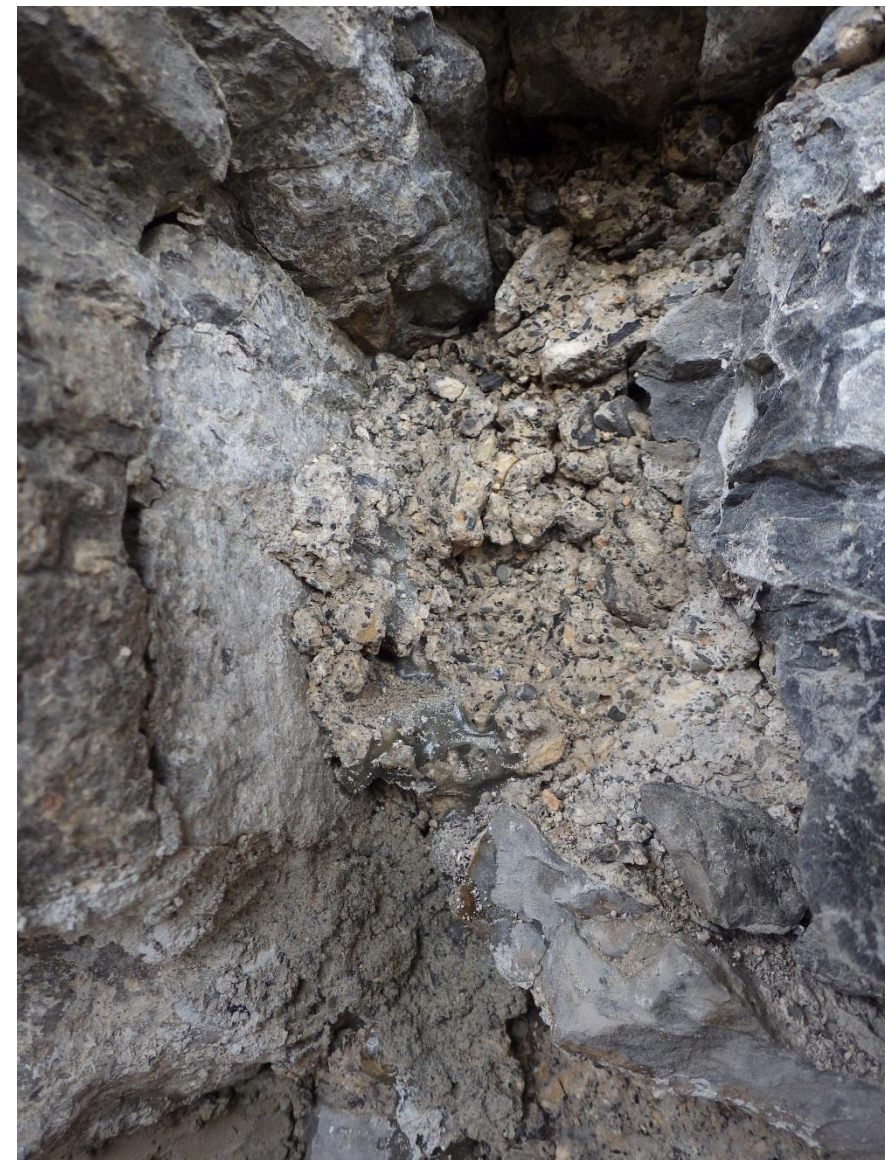
The original lime mortar found in our ruins:

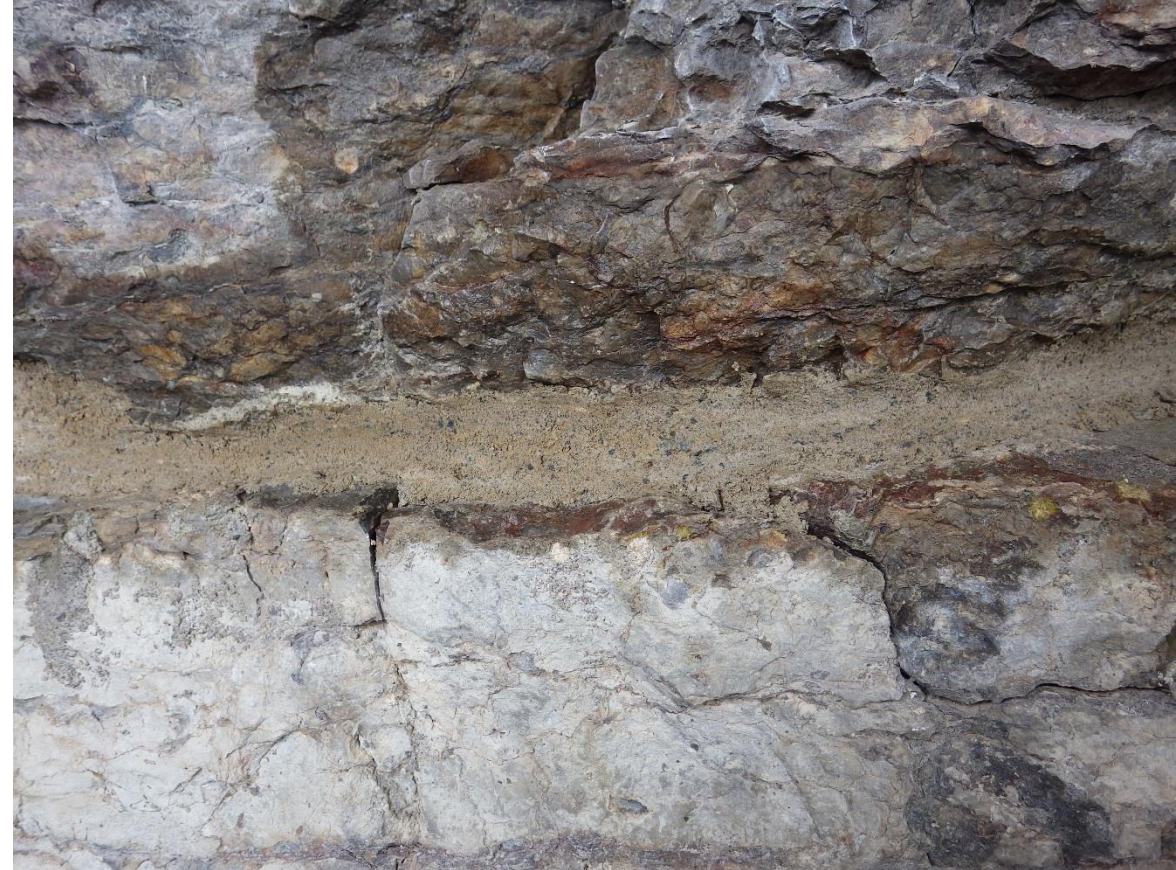
Joint in the keep with our lime mortar, produced at the

museum in 2017.

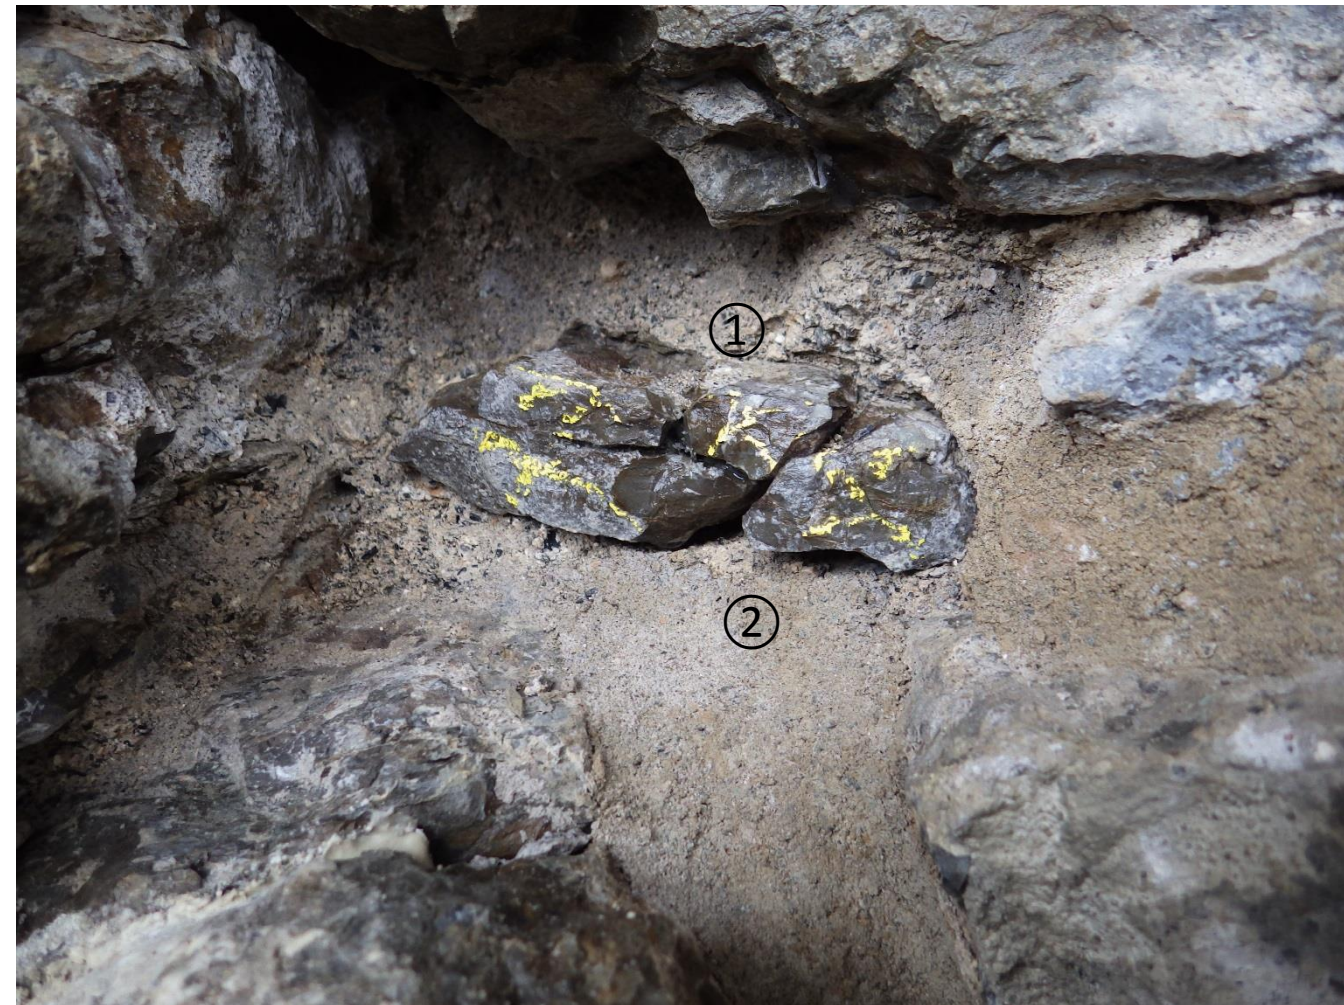
Joint and core with original mortar seen at the top(1), and lime mortar produced at the museum seen to the right and at the bottom(2).

Testing the lime mortar produced at the museum in 2017:

- we tested the lime by dry-slaking it into a dry powder, and then mixed it with water and sand(Ramlo sand 0-4) in the relation 1-1. Then we added a few hands of slate sand.
- At first, the mortar seemed «short» to set in the joints. We therefore placed the mortar in a sealed box for a week. Then it was remixed, without any additions, and the consistence of the mortar had changed dramatically and positively. The mortar now seemed «fat» and more easy to work with.
- The colour of the mortar looks similar to the original lime mortar found in our ruins.
- As the test field with our self-produced mortar started to carbonate, we discovered that the process went surprisingly fast. So far, our experience is that our mortar carbonates much like the NHL 3,5.
