Historic Brickwork in East Anglia: recording jointing and pointing finishes. Pilot Study.

Simon Swann Associates Ltd.

Aims and objectives

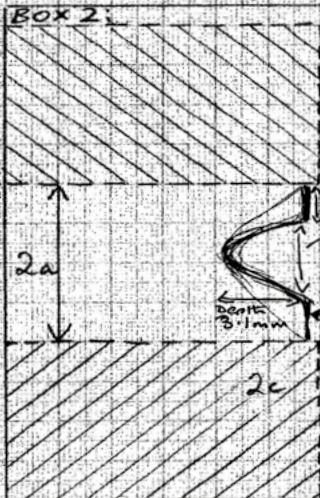
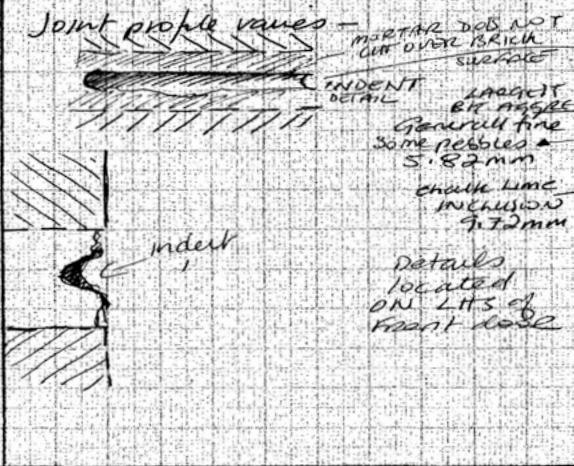
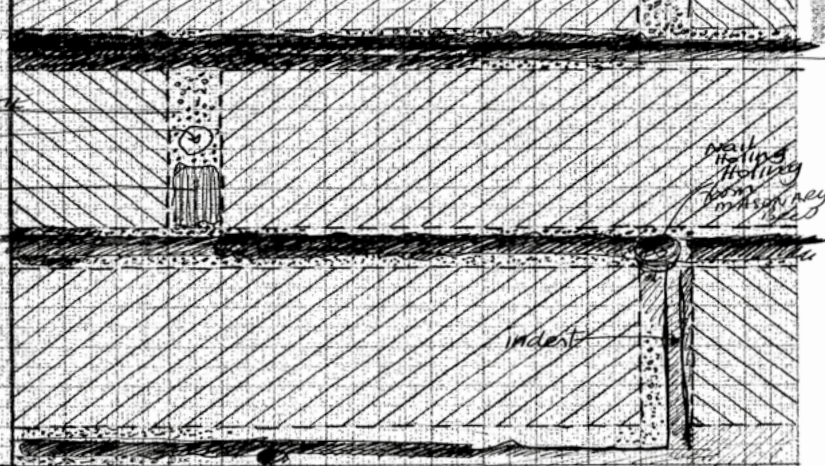
DETAILED RECORD SHEET A
SCAN A

BOX 2: 2: PROVIDE DETAILED SKETCH WITH MEASUREMENTS IN MMS OF JOINT PROFILE.
 2a: RECORD HEIGHT OF BED JOINT = 9.21mm
 2b: MEASURE AND RECORD PROJECTIONS AND INDENTS - indent = 3.1mm - indent varies - 5.15mm
 2c: DRAW IN THE APPROPRIATE PROFILE OF THE BRICK. NOTE ANY "BUTTORING" OVER OF DAMAGED BRICKS WITH MORTAR.
 BOX 3: REFER TO DETAILED RECORD NOTES FOR JOINT TYPE
 BOX 4: RECORD WIDTH OF PERPEND JOINTS (AVERAGE).

* LOCATION TYPE AND COLOUR OF COLOUR WASHES AND PENCILING. Remnants of a white colouring evident - possibly lime wash - chalk / lime inclusions.
 * NOTE SURFACE TEXTURE AND COLOUR OF JOINTING MORTAR. Lumps - but generally fine mortar.

* NOTE COLOUR OF CONSTRUCTION MORTAR IF DIFFERENT FROM SURFACE JOINTING (IF VISIBLE). Colours same as pointing mortar - chalky white.

BRICK DIMENSION: L = 8.9"
 W = Difficult to record approx. 4"
 H = 2.14"
 BRICK COLOUR: Polychrome brick - all headers are dark faced. STRETCHERS ARE ORANGE BRICK with general meaner accent at lower levels.
 BRICK GAUGE: 270mm
 BRICK BOND: FLEMISH
 BRICK TYPE: ORANGE COLOUR - STRETCHERS
 vitrified BRICK

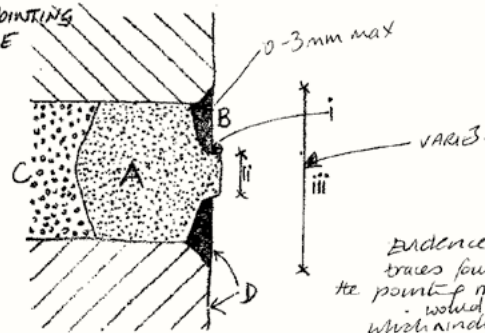
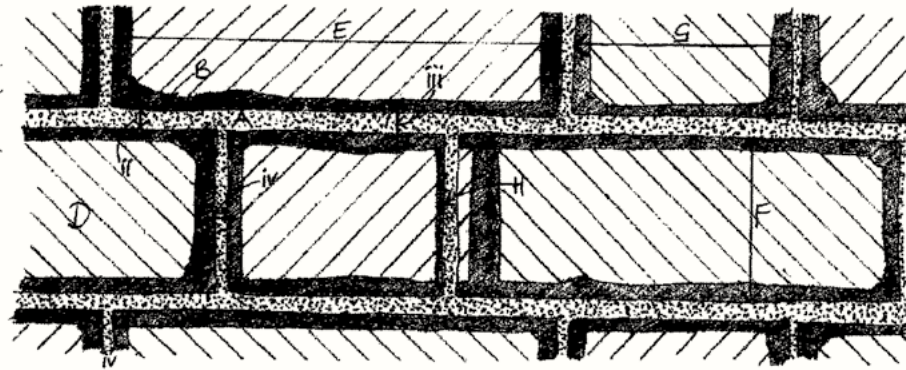
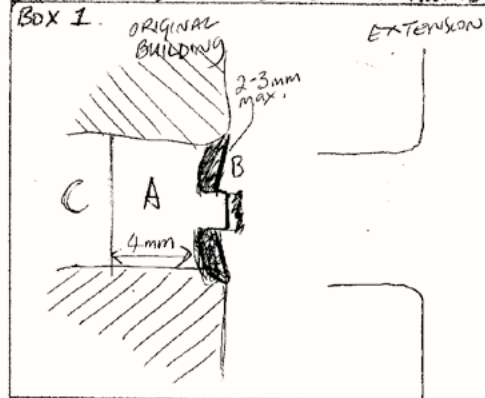
WIG POINTING RECORD SURVEY SHEET 7491 HISTORIC BRICKWORK EAST ANGLIA.

Evidence of pigment traces found behind the pointing mortar which indicates a red wash was on the surface before the wig pointing with wire.

MORTAR COLOUR	MEASUREMENTS IN MM'S:	SETTING OUT: (TAKE 3 MEASUREMENTS FOR EACH DIMENSION)
A. POINTING MORTAR: WHITE	0.87 mm 0.48 mm 1.12 mm 0.90 mm	E. WIDTH BETWEEN STRETCHER PERPEND RIBBONS E1. 220 mm E2. 228 mm E3. 235 mm

B. STOPPING MORTAR: RED	5.79 mm 6.05 mm 5.21 mm	F. HEIGHT BETWEEN "BED" JOINT RIBBONS F1. 58.2 mm F2. 59.8 mm F3. 62.4 mm
C. BEDDING MORTAR (IF VISIBLE) <i>check colour slightly max beige in colour than pointing mortar</i>	7.57 mm 4.62 mm	G. WIDTH BETWEEN HEADER PERPEND RIBBONS G1. 109 mm G2. 110.5 mm G3. 110.6 mm

D. PIGMENT WASH (IF PRESENT) <i>NONE PRESENT</i>	4.7 mm 4.4 mm 3.4 mm	H. ARE FAUX JOINTS PRESENT? <i>definitely present in extension (southern) score lines there are in the brick work to plumb the perpend into the face of the butt-p.</i>
NOTE: BRICK COLOUR: ORANGE/RED	NOTES: measurements vary lime rich with <i>pointing</i> mortar with horizontal cracking & very fine sand aggregate

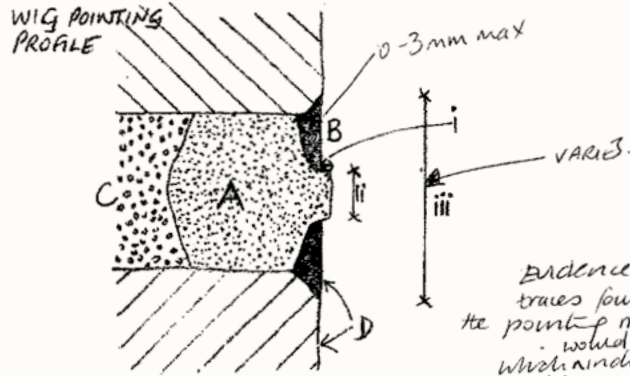
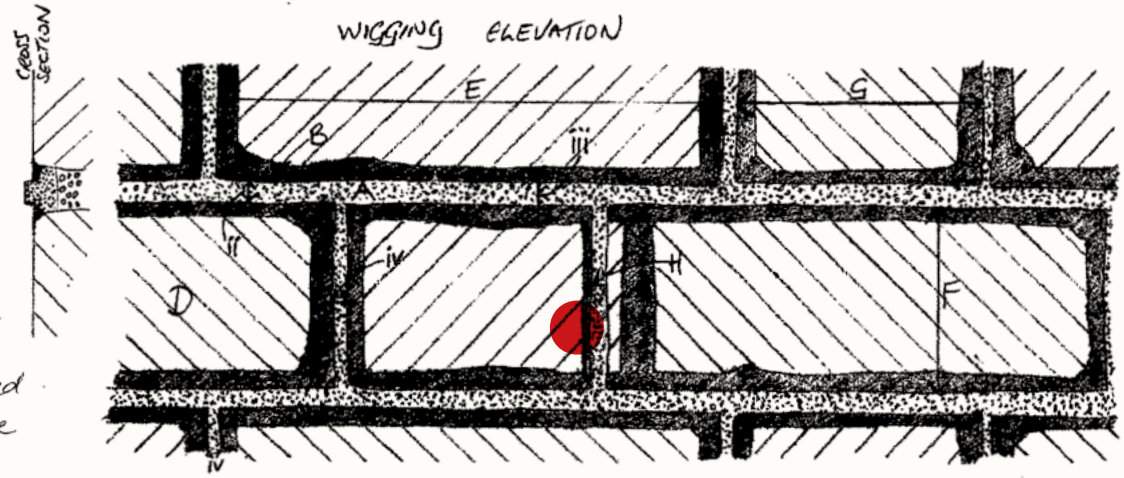
WIG POINTING RECORD SURVEY SHEET 7491 HISTORIC BRICKWORK EAST ANGLIA.

Evidence of a pigment wash found behind the pointing mortar which indicates a red wash was on the surface before the wig pointing was done.

BOX 1. ORIGINAL BUILDING 	EXTENSION 	MORTAR COLOUR A. POINTING MORTAR: WHITE B. STOPPING MORTAR: RED C. BEDDING MORTAR (IF VISIBLE): CHALK colour slightly max beige in colour than pointing mortar D. PIGMENT WASH (IF PRESENT): NONE PRESENT	MEASUREMENTS IN MM'S: i PROJECTION OF "RIBBON": 0.87mm, 0.148mm, 1.12mm, 0.90mm (VARIES) ii HEIGHT OF "BED RIBBON": 5.79mm, 6.05mm, 5.21mm (VARIES) iii HEIGHT OF BED JOINT: 7.57mm, 4.62mm iv WIDTH OF PERPEND "RIBBON": 4.7mm, 4.4mm, 3.4mm	SETTING OUT: (TAKE 3 MEASUREMENTS FOR EACH DIMENSION) E. WIDTH BETWEEN STRETCHER PERPEND RIBBONS: E1 220mm, E2 228mm, E3 235mm F. HEIGHT BETWEEN "BED" JOINT RIBBONS: F1 58.2mm, F2 59.8mm, F3 62.4mm G. WIDTH BETWEEN HEADER PERPEND RIBBONS: G1 109mm, G2 110.5mm, G3 110.6mm
		NOTE: BRICK COLOUR: ORANGE/RED	NOTES: measurements vary lime rich with strong pointing mortar with horizontal cracking & very fine sand aggregate	H. ARE FAUX JOINTS PRESENT? ^{definitely present in extension} ^(southern extension) evident in the brick work to plumb the building: perpend into the face of the building.

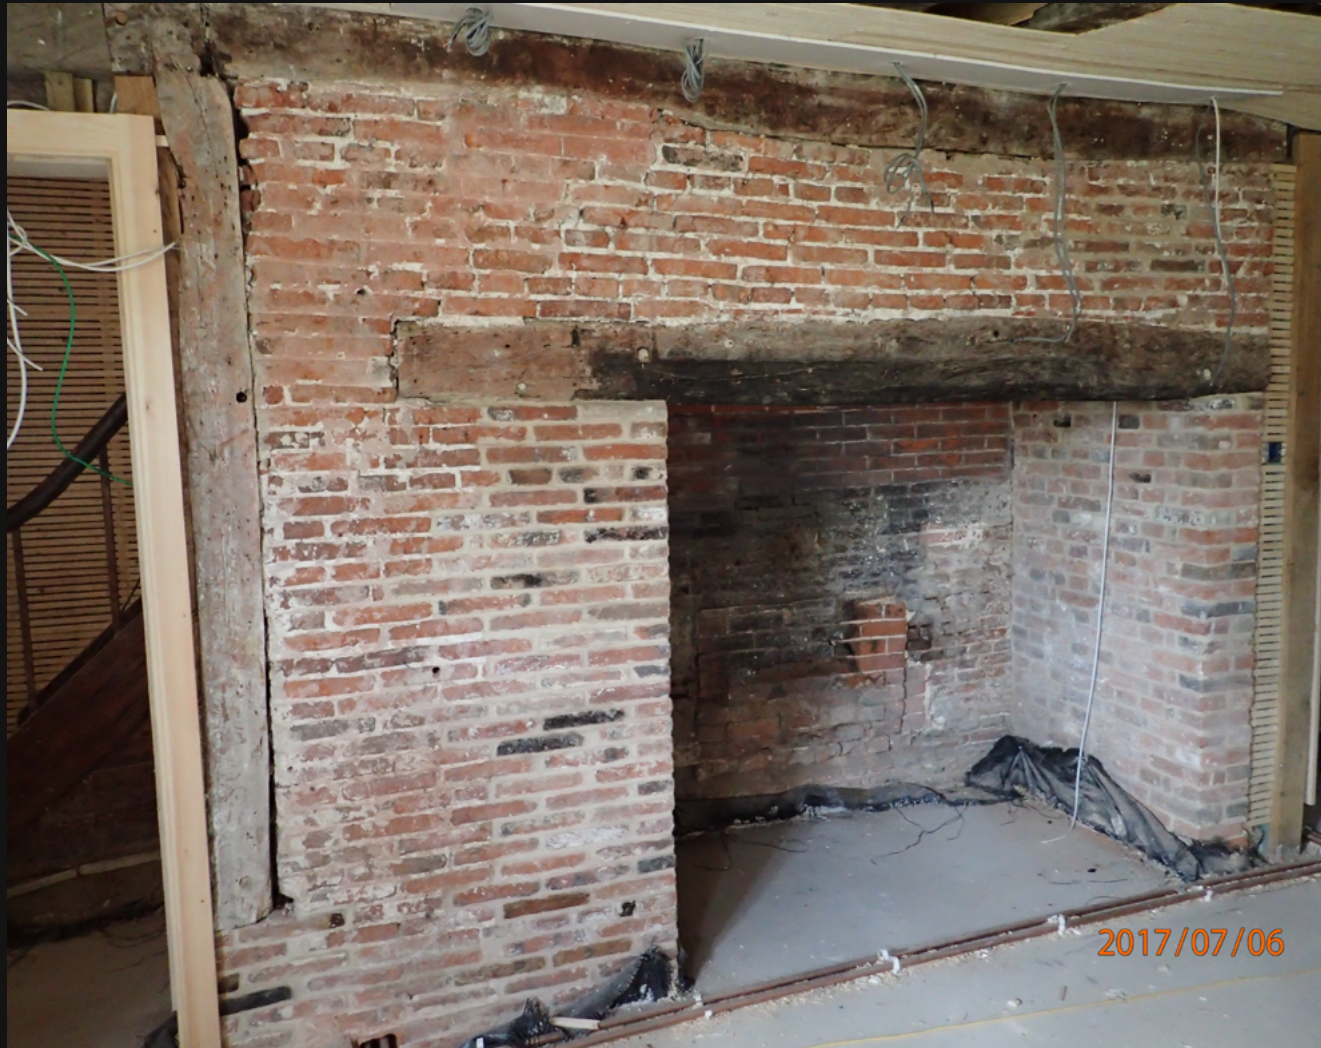
Fireplace in timber-framed building with ruddled brickwork and flush, or under struck, jointing. Probably 16th c.

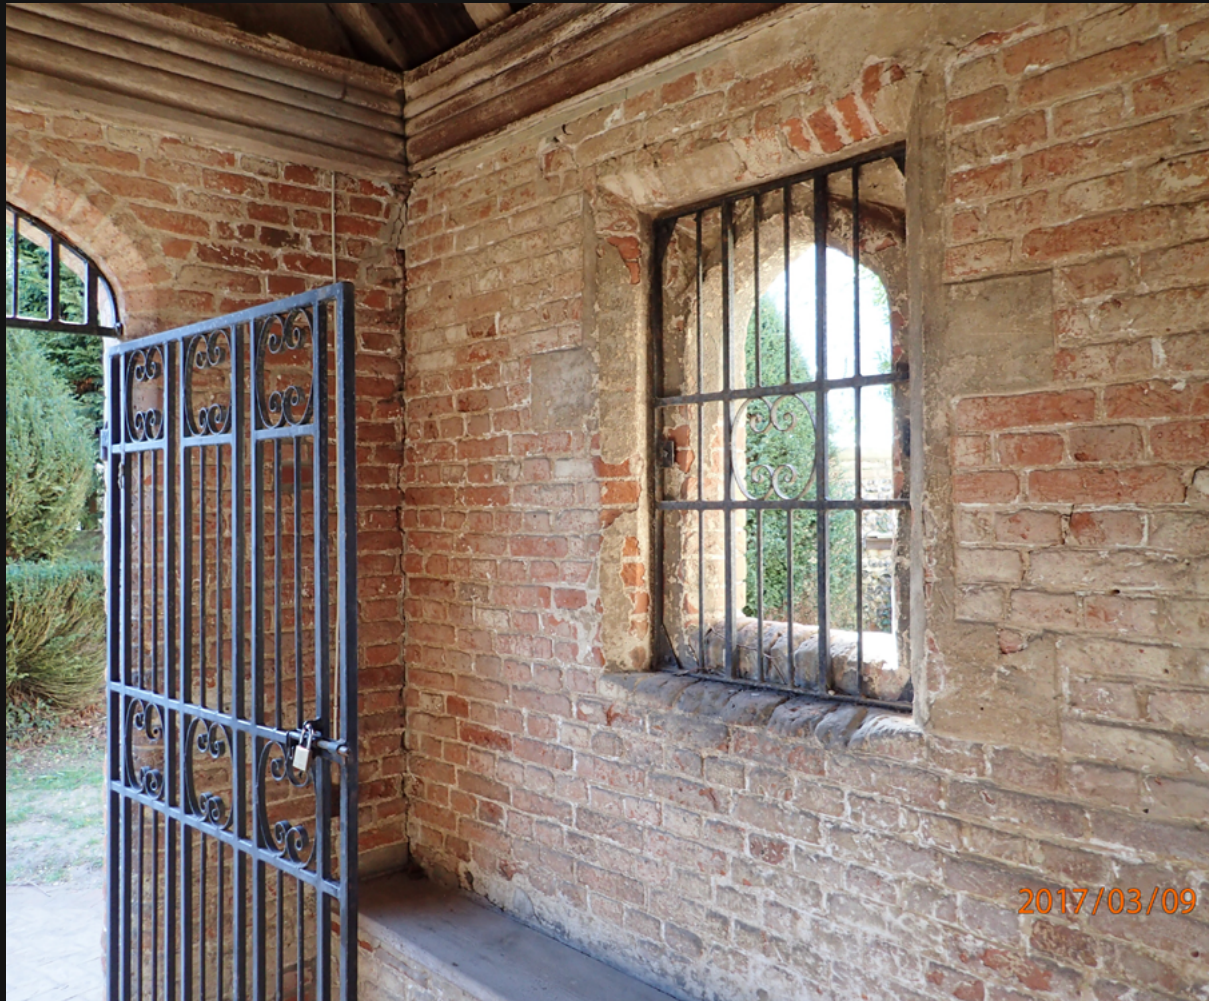
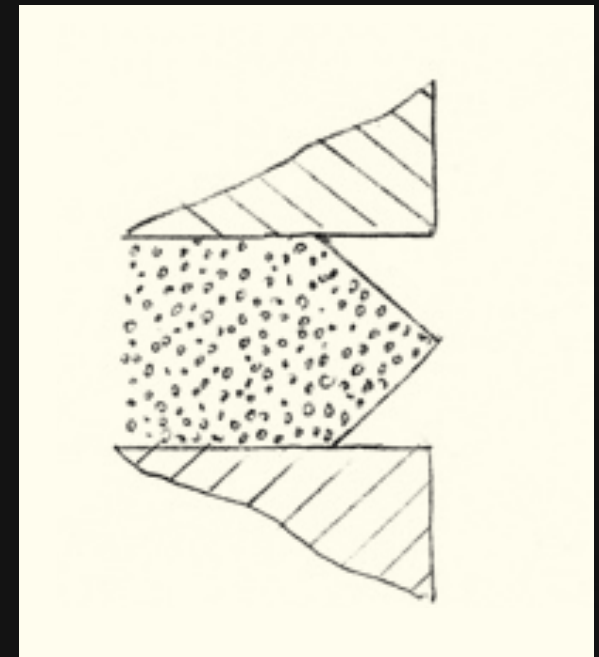
Sixteenth century porch to Borley church, Essex. Interior double struck jointing, ruddled with surviving thin render 'imitation stone' detailing to window jambs.
